MICHIGAN DEPARTMENT OF
ENVIRONMENT, GREAT LAKES, AND ENERGY

Shoreline Trends and Best Management Practices: Combatting cumulative impacts through homeowner scale techniques

WETLANDS, LAKES, AND STREAMS PROGRAM

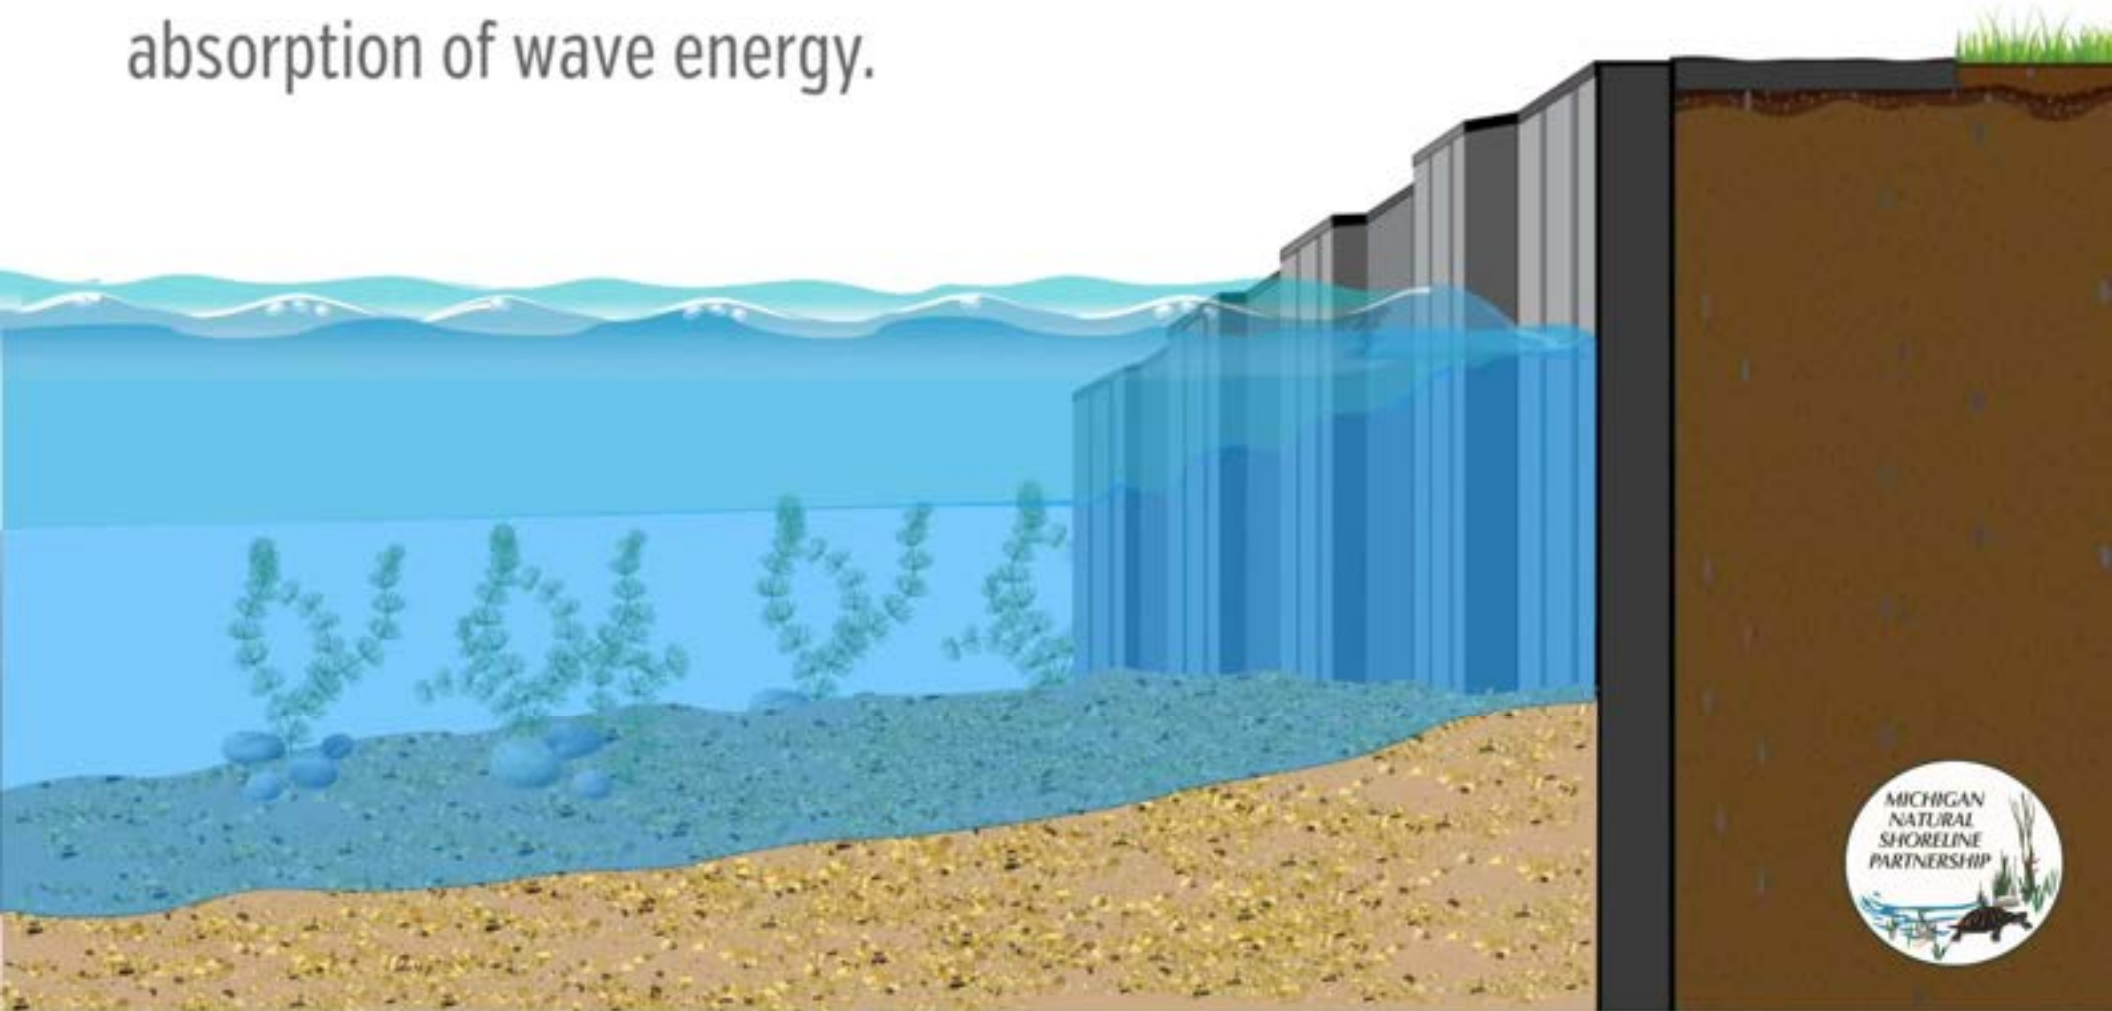
Seawalls do not allow for the absorption of wave energy.

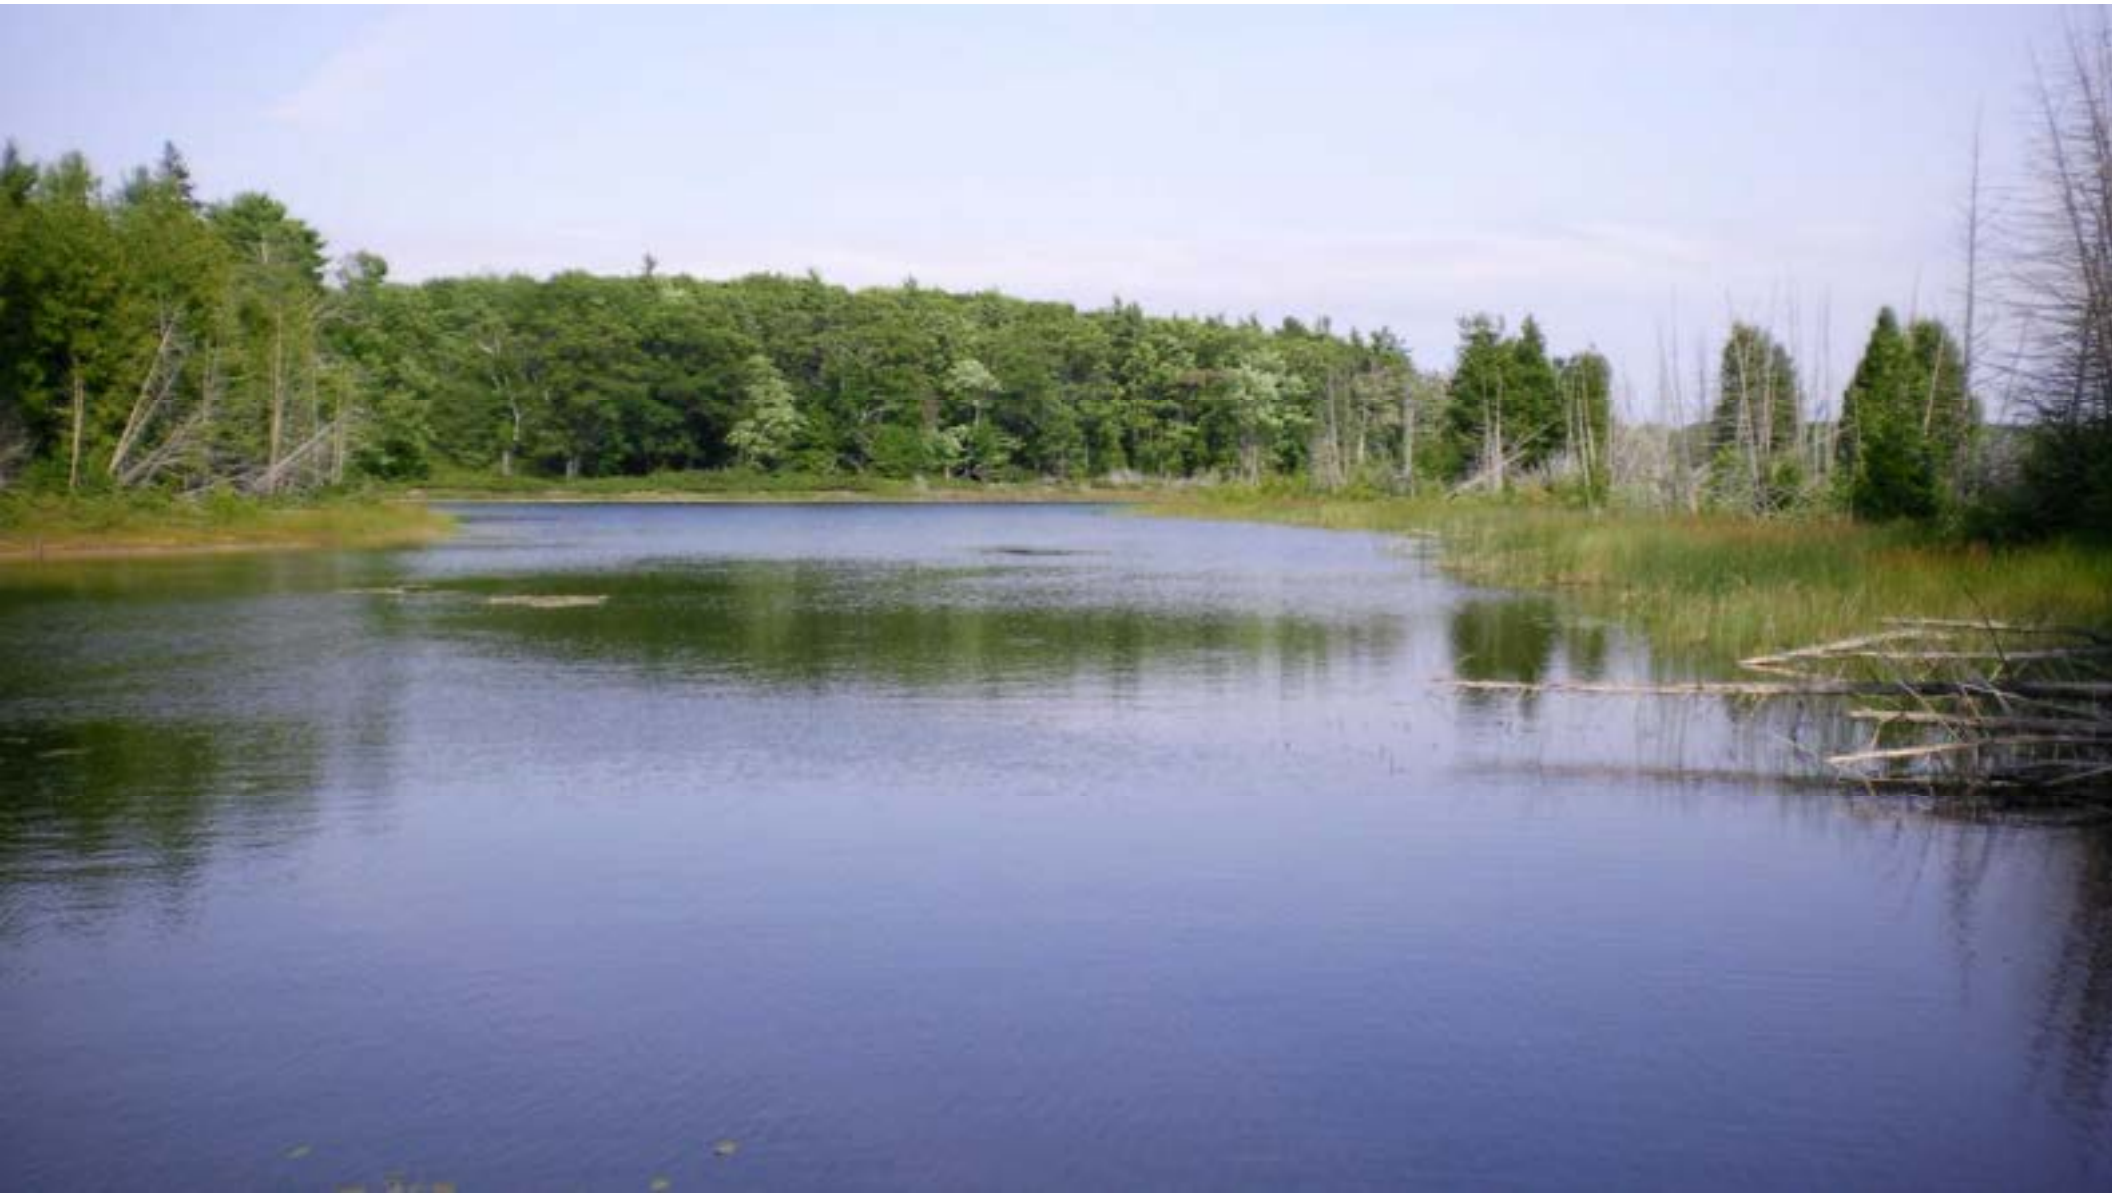
- SCOURING OF THE LAKE BOTTOM AND EROSION OF NEIGHBORING PROPERTIES
- SEDIMENT SUSPENSION, NUTRIENT SUSPENSION LOWERS WATER QUALITY
- DOESN'T SUPPORT AQUATIC PLANT GROWTH AND NATURAL SHORELINE VEGETATION
- NO HABITAT COMPLEXITY FOR FISH AND WILDLIFE
- CREATE BARRIER FOR ANIMAL MOVEMENT
- REMOVE NATURAL ENERGY DISSIPATING CAPACITY OF SLOPED SHORELINE AND NATURAL VEGETATION

Seawalls deflect waves and cause scouring of the lake bottom.

Sediments that are churned up from the lake bottom often contain phosphorus that can cause nuisance algae growth.

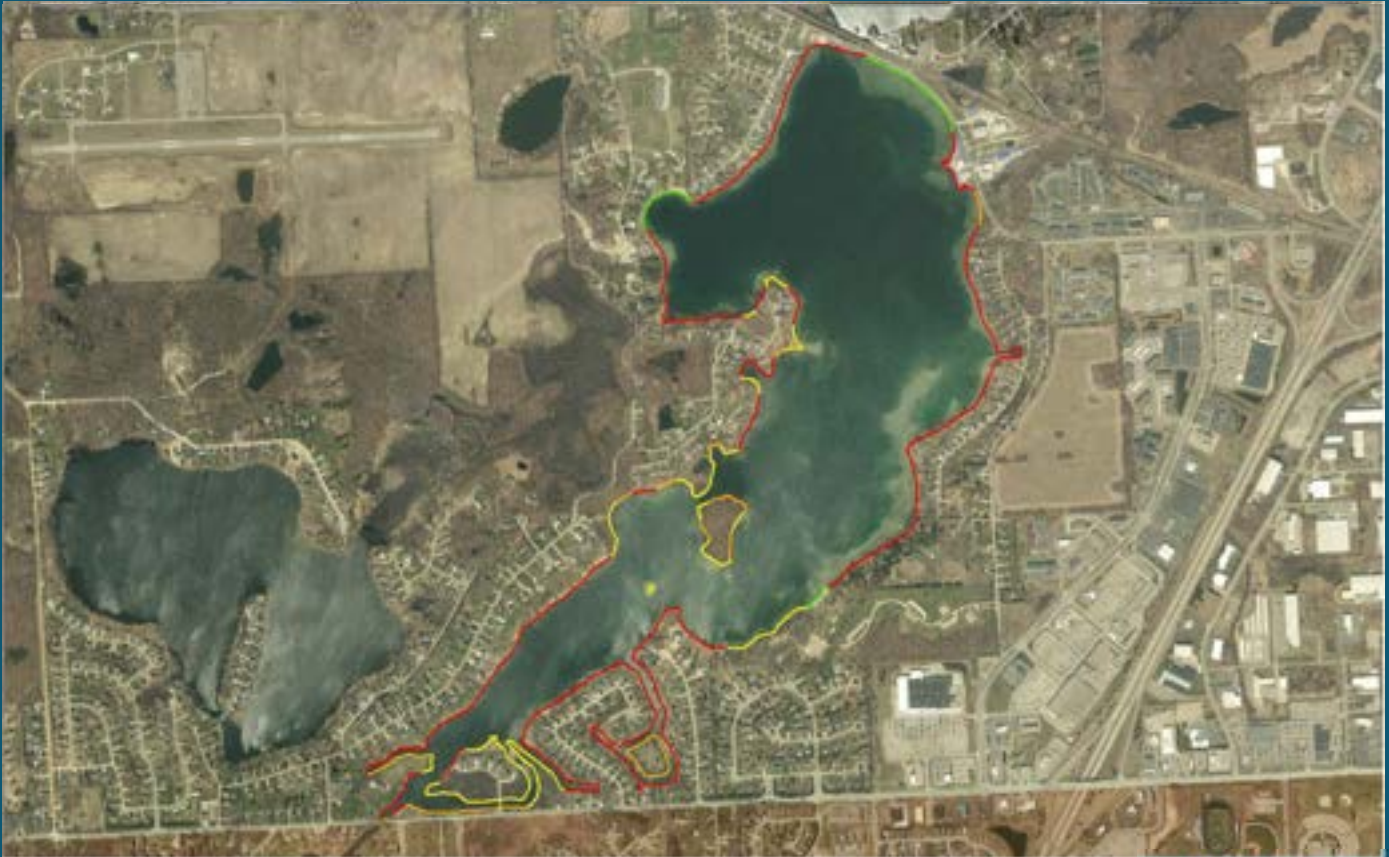
SILVER LAKE, GENESEE COUNTY

-   UNDEVELOPED UPLAND SHORELINE – UNDEVELOPED VEGETATED UPLAND AREAS
-   WETLAND SHORELINE – EMERGENT WETLAND VEGETATION
-   DEVELOPED SHORELINE – GRASS TO THE WATERS EDGE, STRUCTURES AND ROADS NEXT TO WATER
-   HARDENED SHORELINE – SEAWALLS, RIPRAP

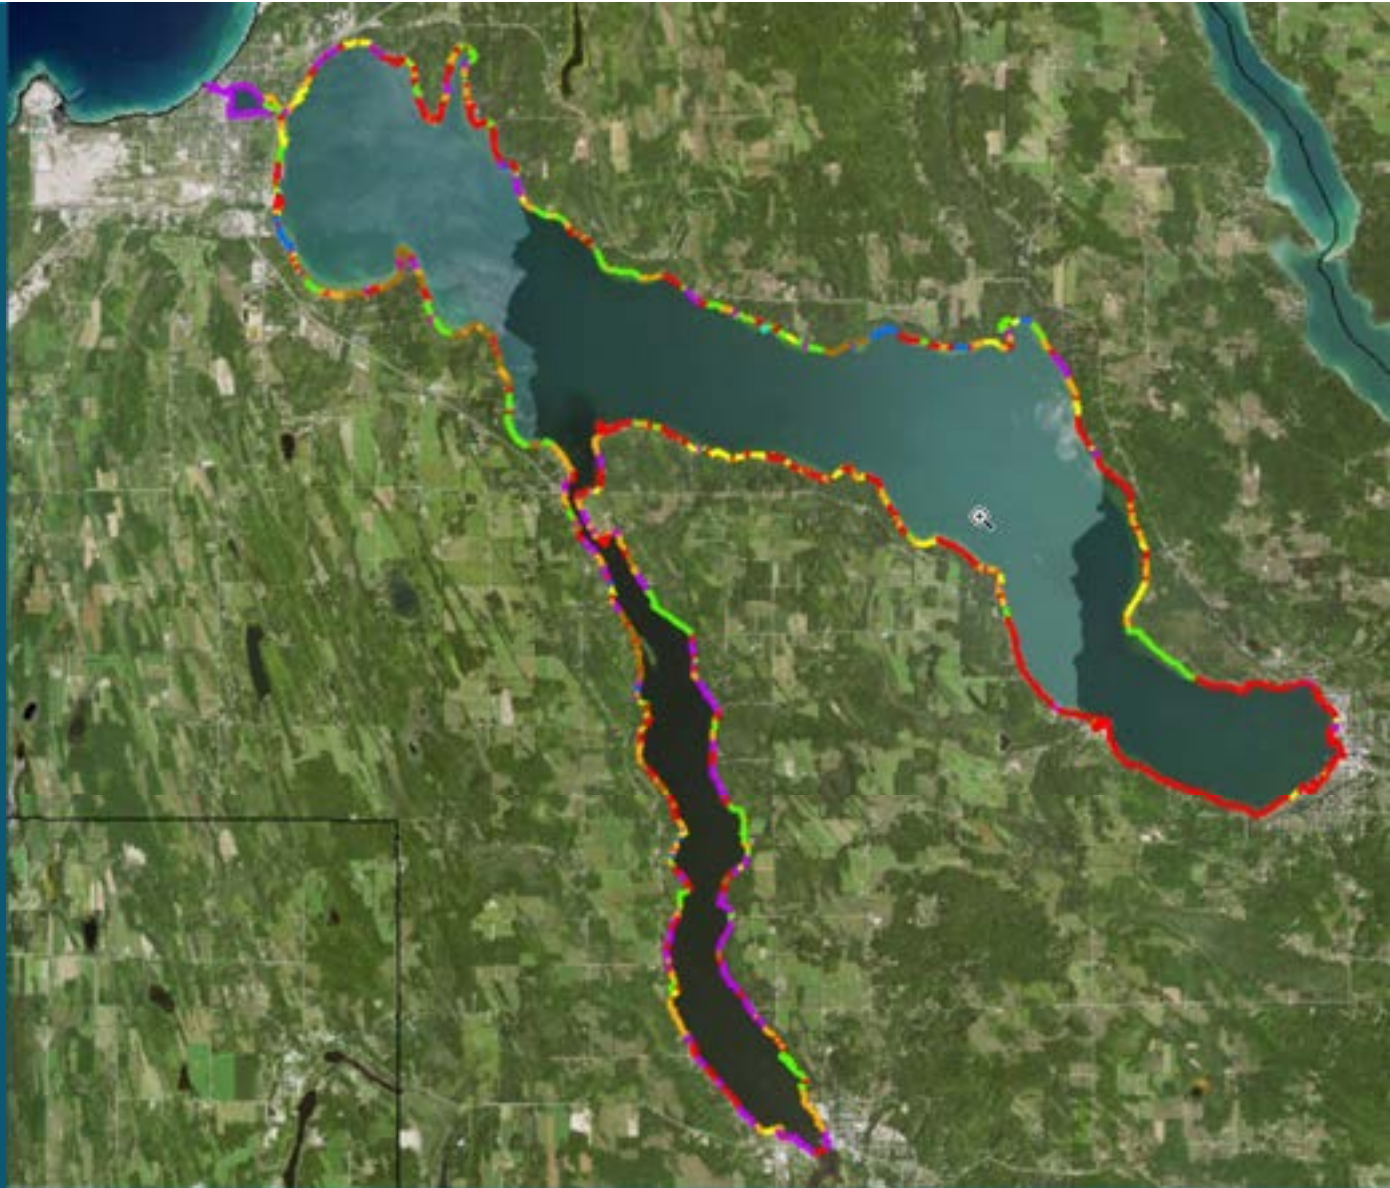
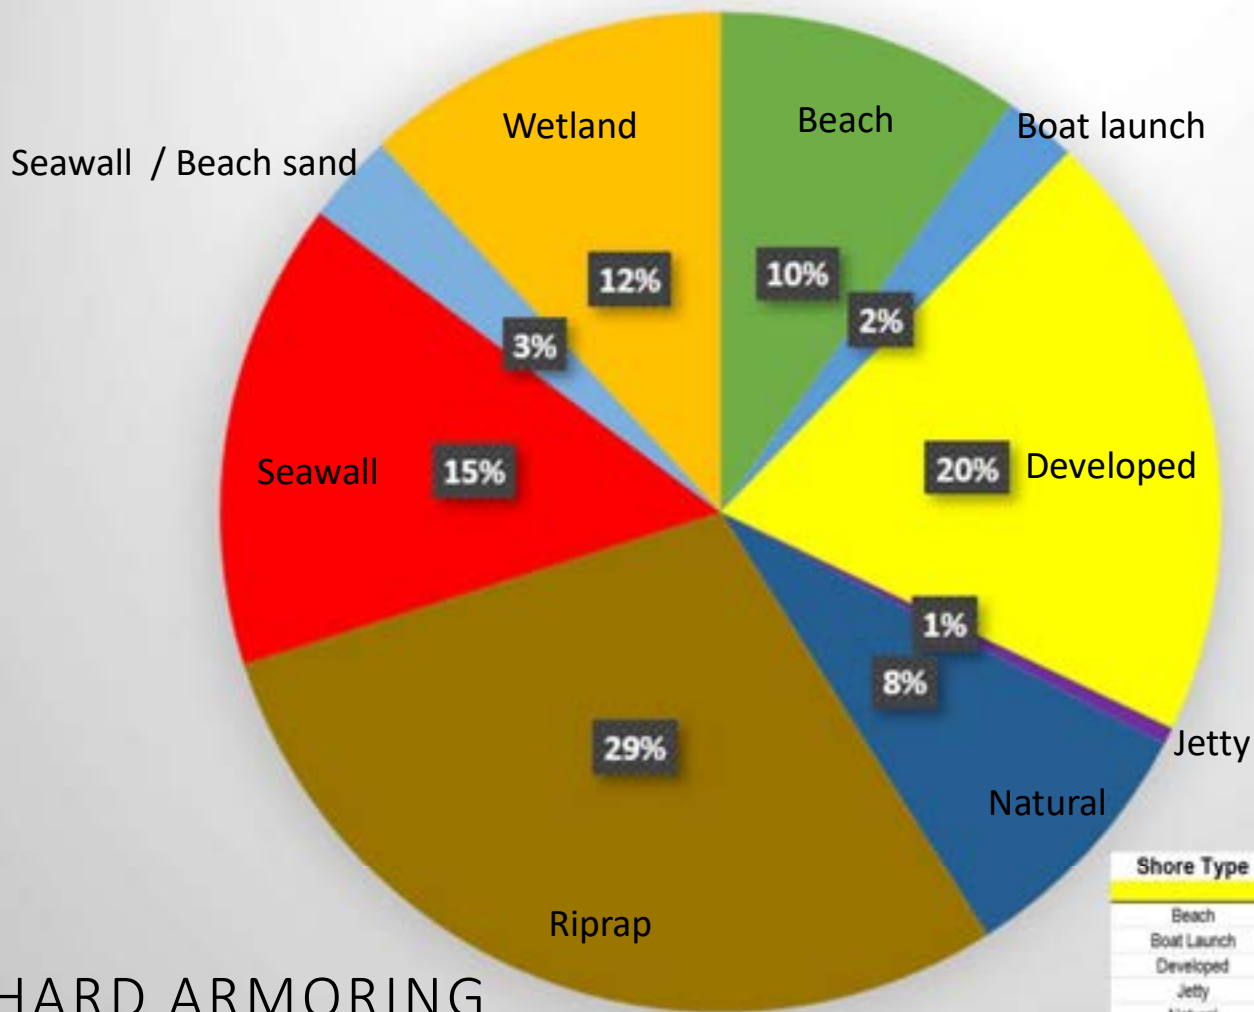
2020ShorelineInventory

- Beach
- Boat Launch**
- Developed
- Jetty
- Natural
- Rip Rap
- Seawall
- Seawall/Beachsand
- Wetland

Shore Type	Shore Type Count	Total Length (ft)	Total Length (mi)
Beach	54	22048.5	4.2
Boat Launch	13	2178	0.4
Developed	109	49885.8	9.4
Jetty	3	1272.1	0.2
Natural	46	24184.3	4.6
Rip Rap	159	118888.8	22.5
Seawall	83	85266.4	10.5
Seawall/Beachsand	16	7055.4	1.3
Wetland	65	53853.2	10.2
TOTAL	548	334,432.50	63.34

50% HARD ARMORING

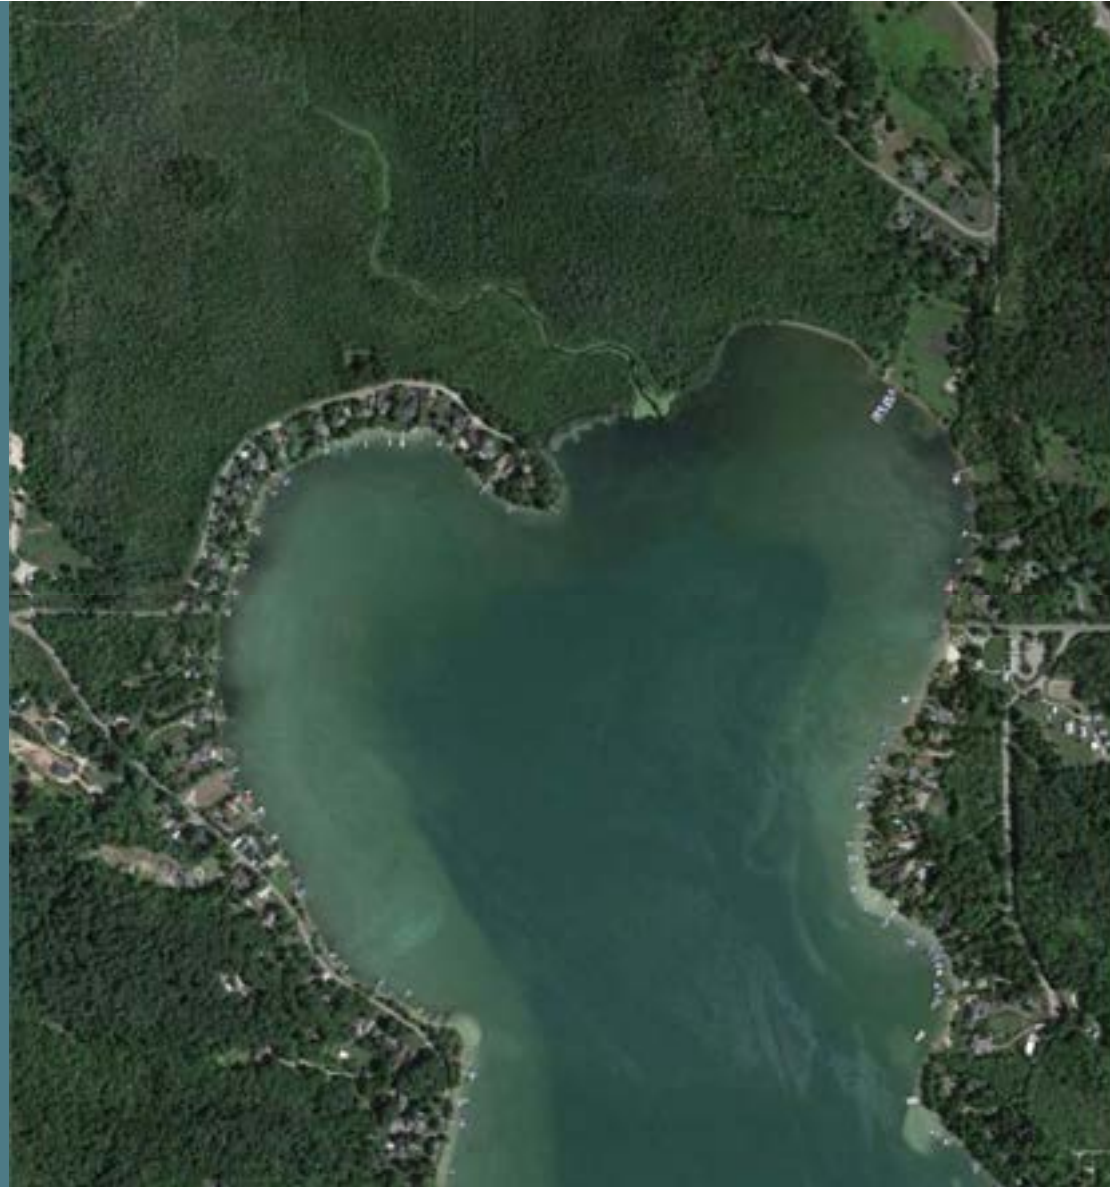
WALLOON LAKE,
EMMET COUNTY

1952
↓
2019

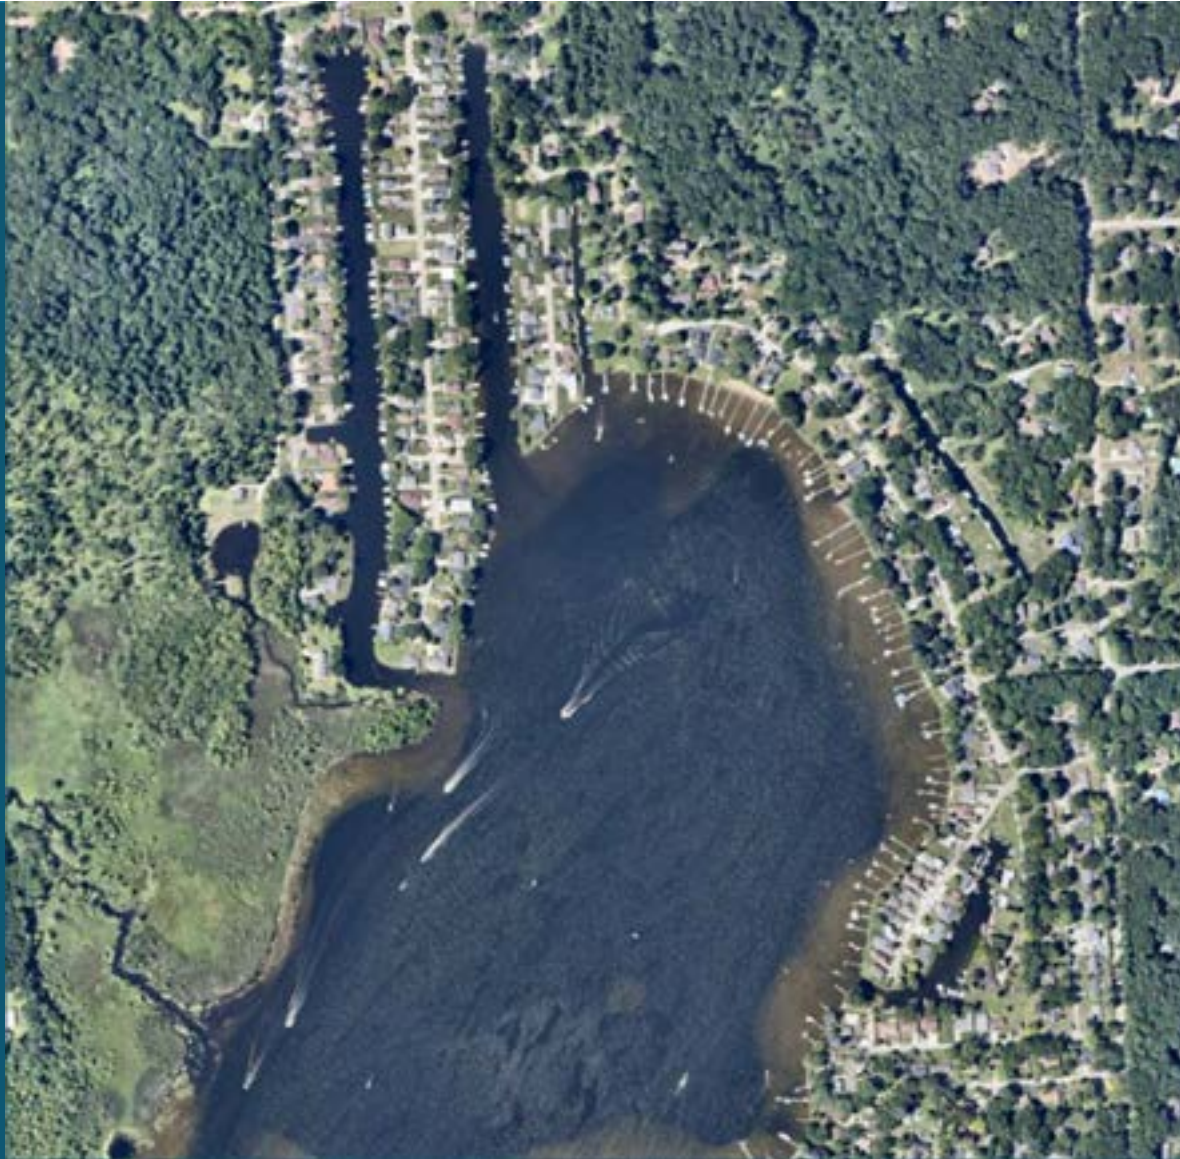
GUN LAKE,
BARRY COUNTY

1938
↓
2014

2022

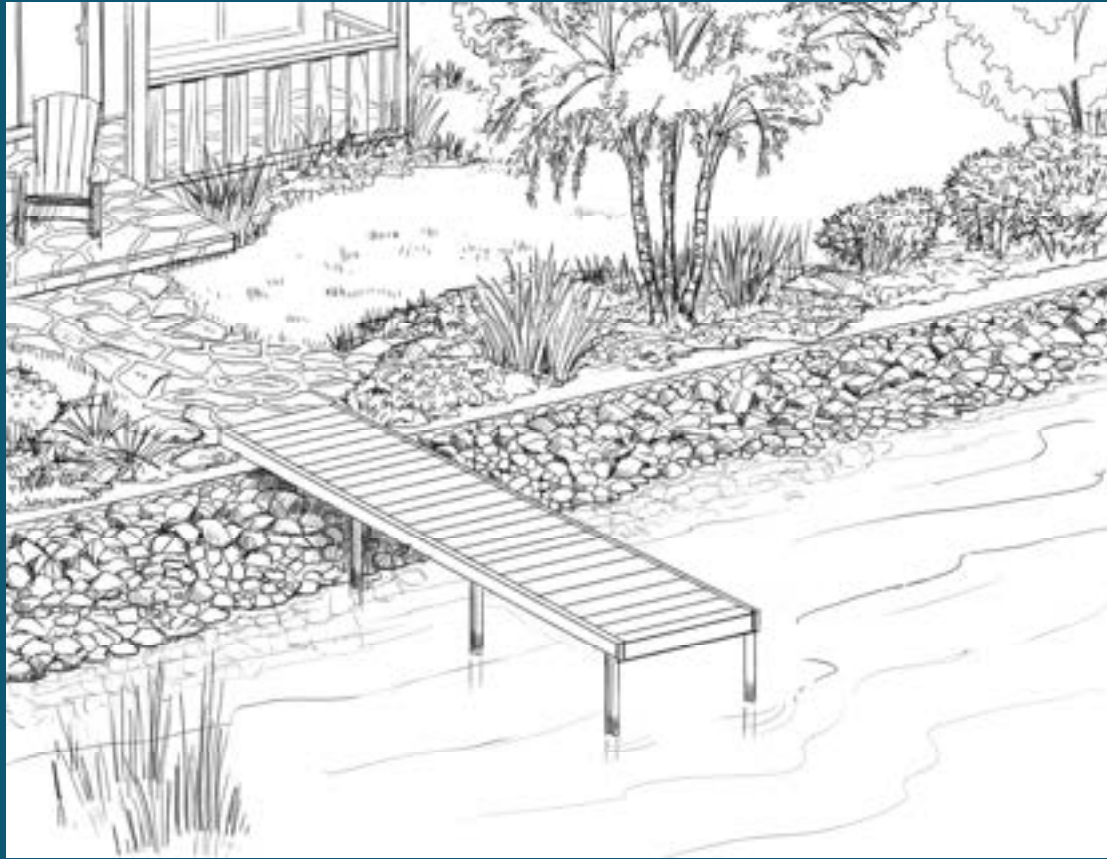
ALLOW FOR ENERGY DISSIPATION

6FT WIDE BUFFER ALONG ENTIRE SEAWALL LENGTH

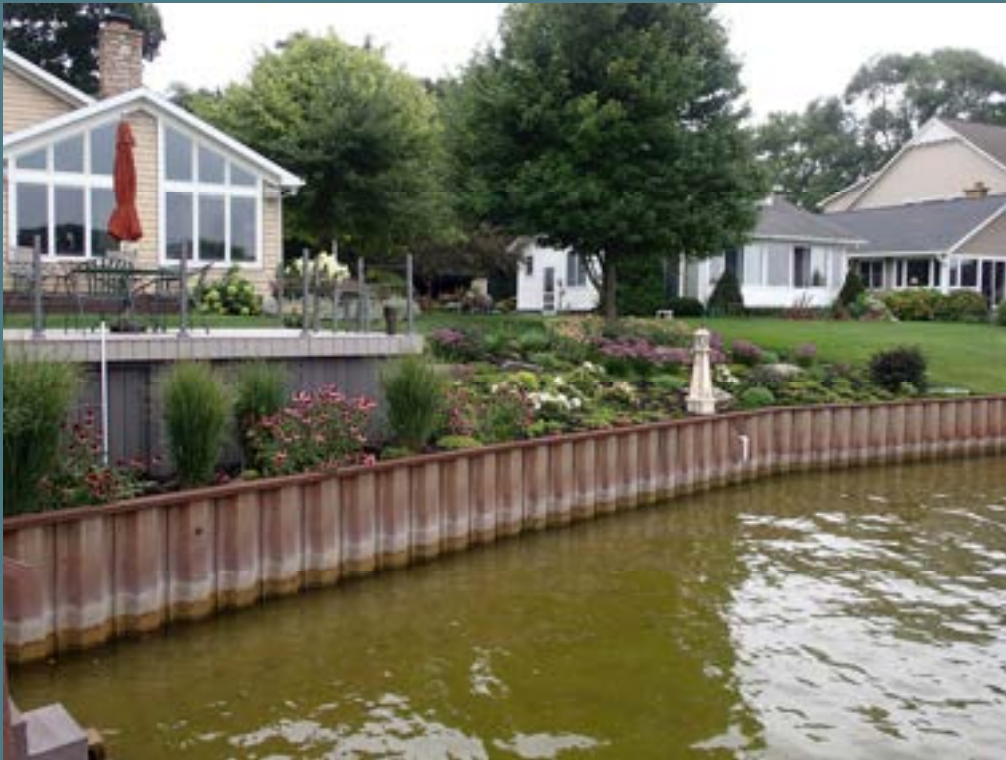
6ft Buffer along entire seawall length

- DIFFERENT BUFFER ORIENTATIONS ARE OKAY IF DIRECTLY BEHIND THE FULL LENGTH OF THE WALL IS NOT POSSIBLE
 - MUST PROVIDE A CLEAR AND DIRECT BENEFIT
 - SWALE OR DISCHARGE AREAS
- PLANTING OR SEEDING IS ACCEPTABLE
- PLANTING PLAN AND SPECIES LIST

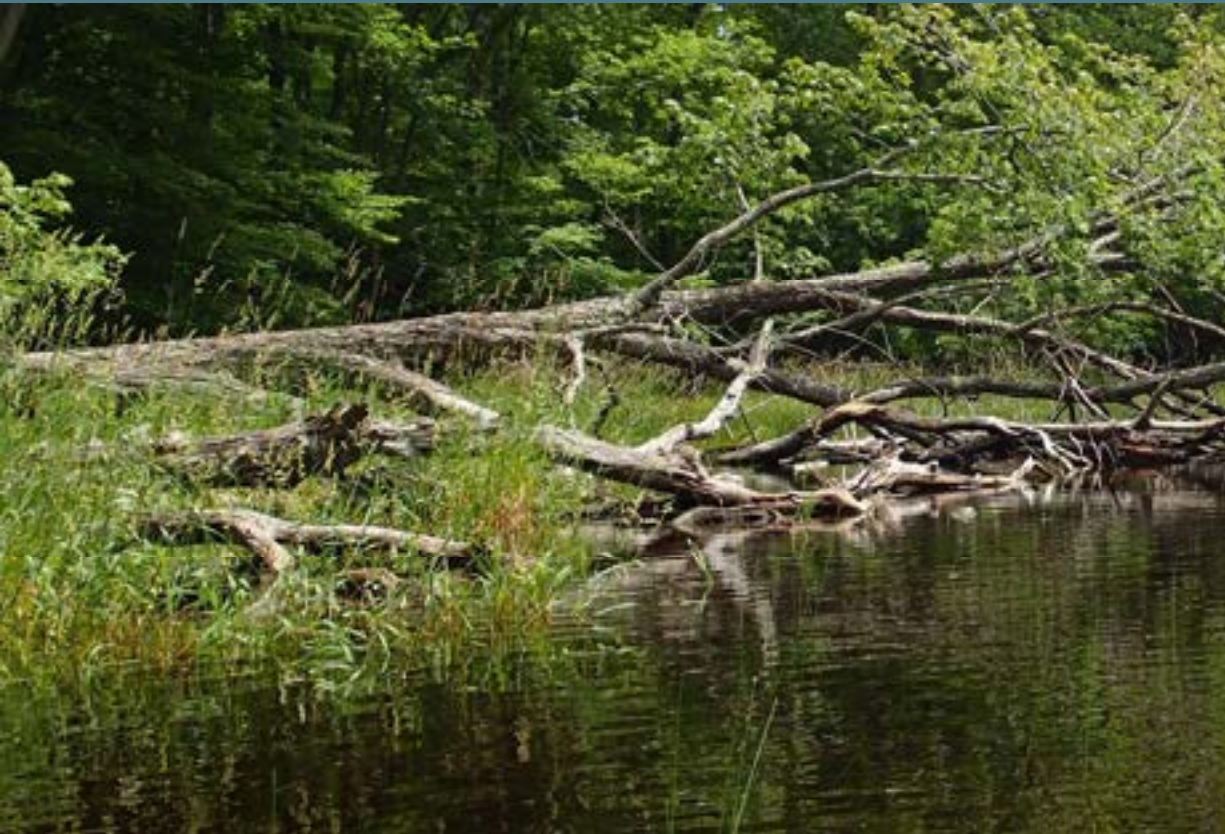
Shoreline woody structure

- PROJECT DESIGNS THAT MIMIC NATURAL PROCESSES
- IN GENERAL – 1 SINGLE TREE PER 25FT OF SEAWALL SINGLE OR CLUSTERED
- ACCEPTABLE TYPES
 - FISH STICK CLUSTER
 - SINGLE FISH STICK
 - TURTLE LOGS
- NOT IMPEDING NAVIGATION
- ANCHORED SECURELY

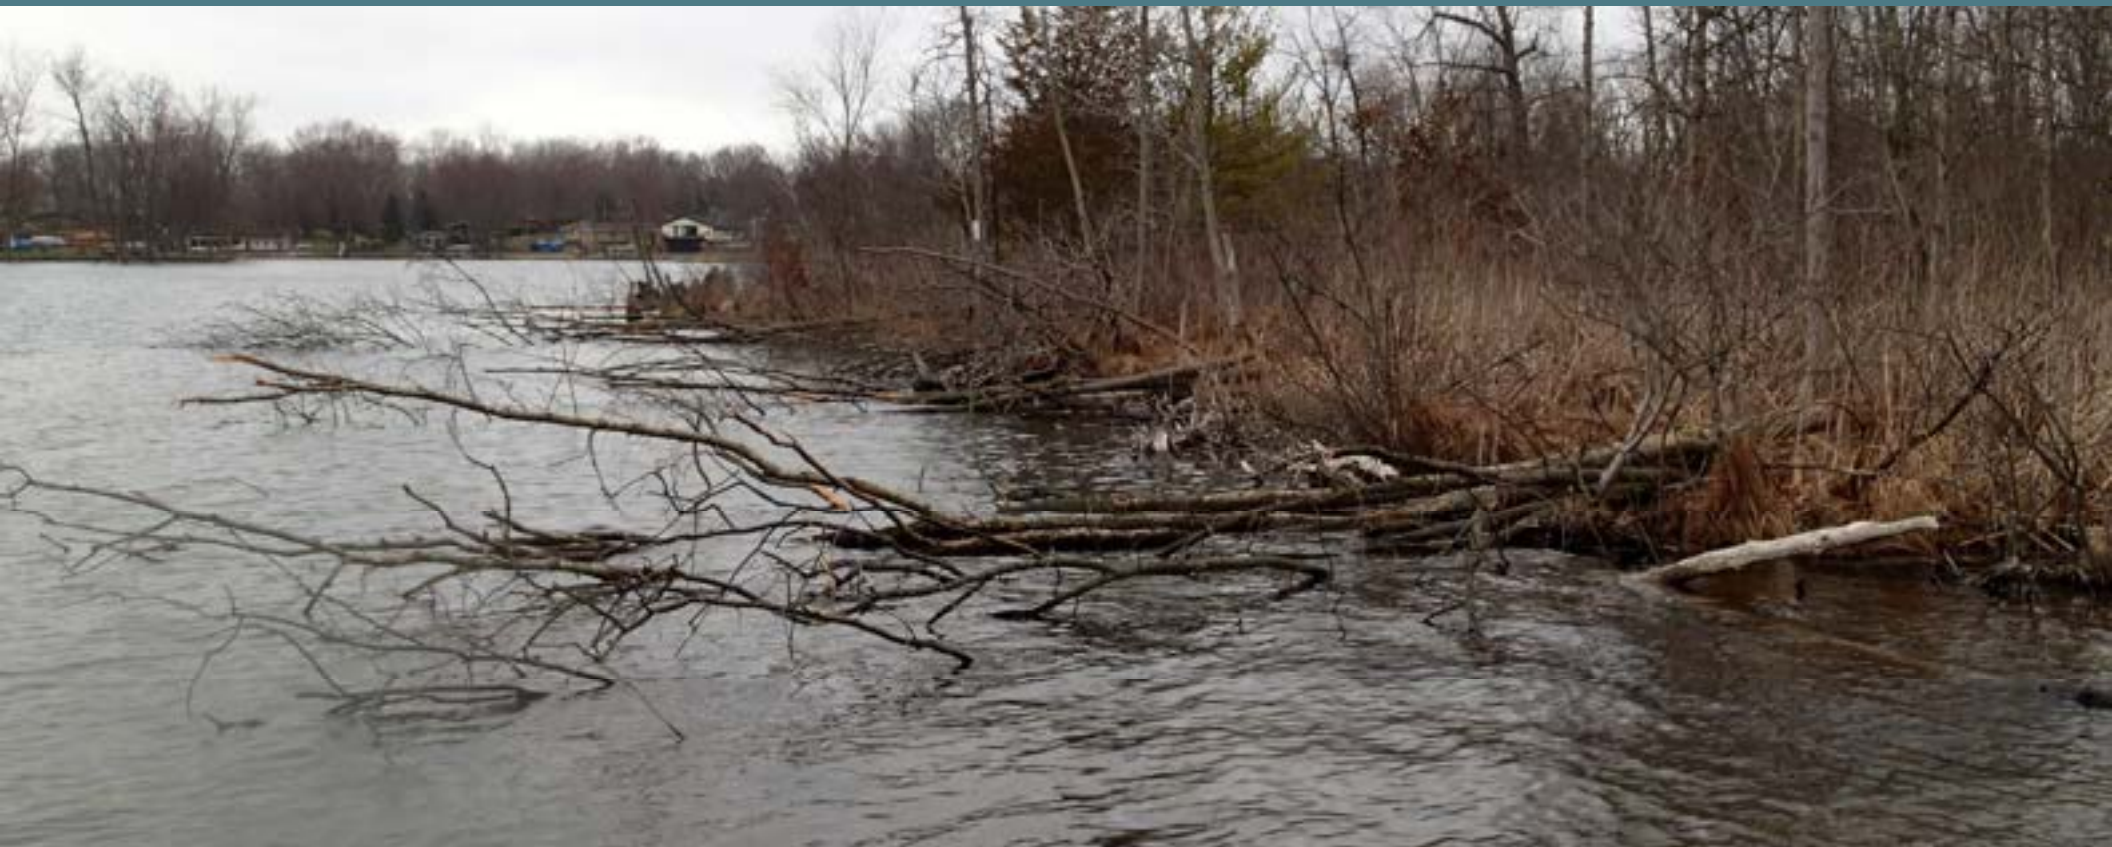
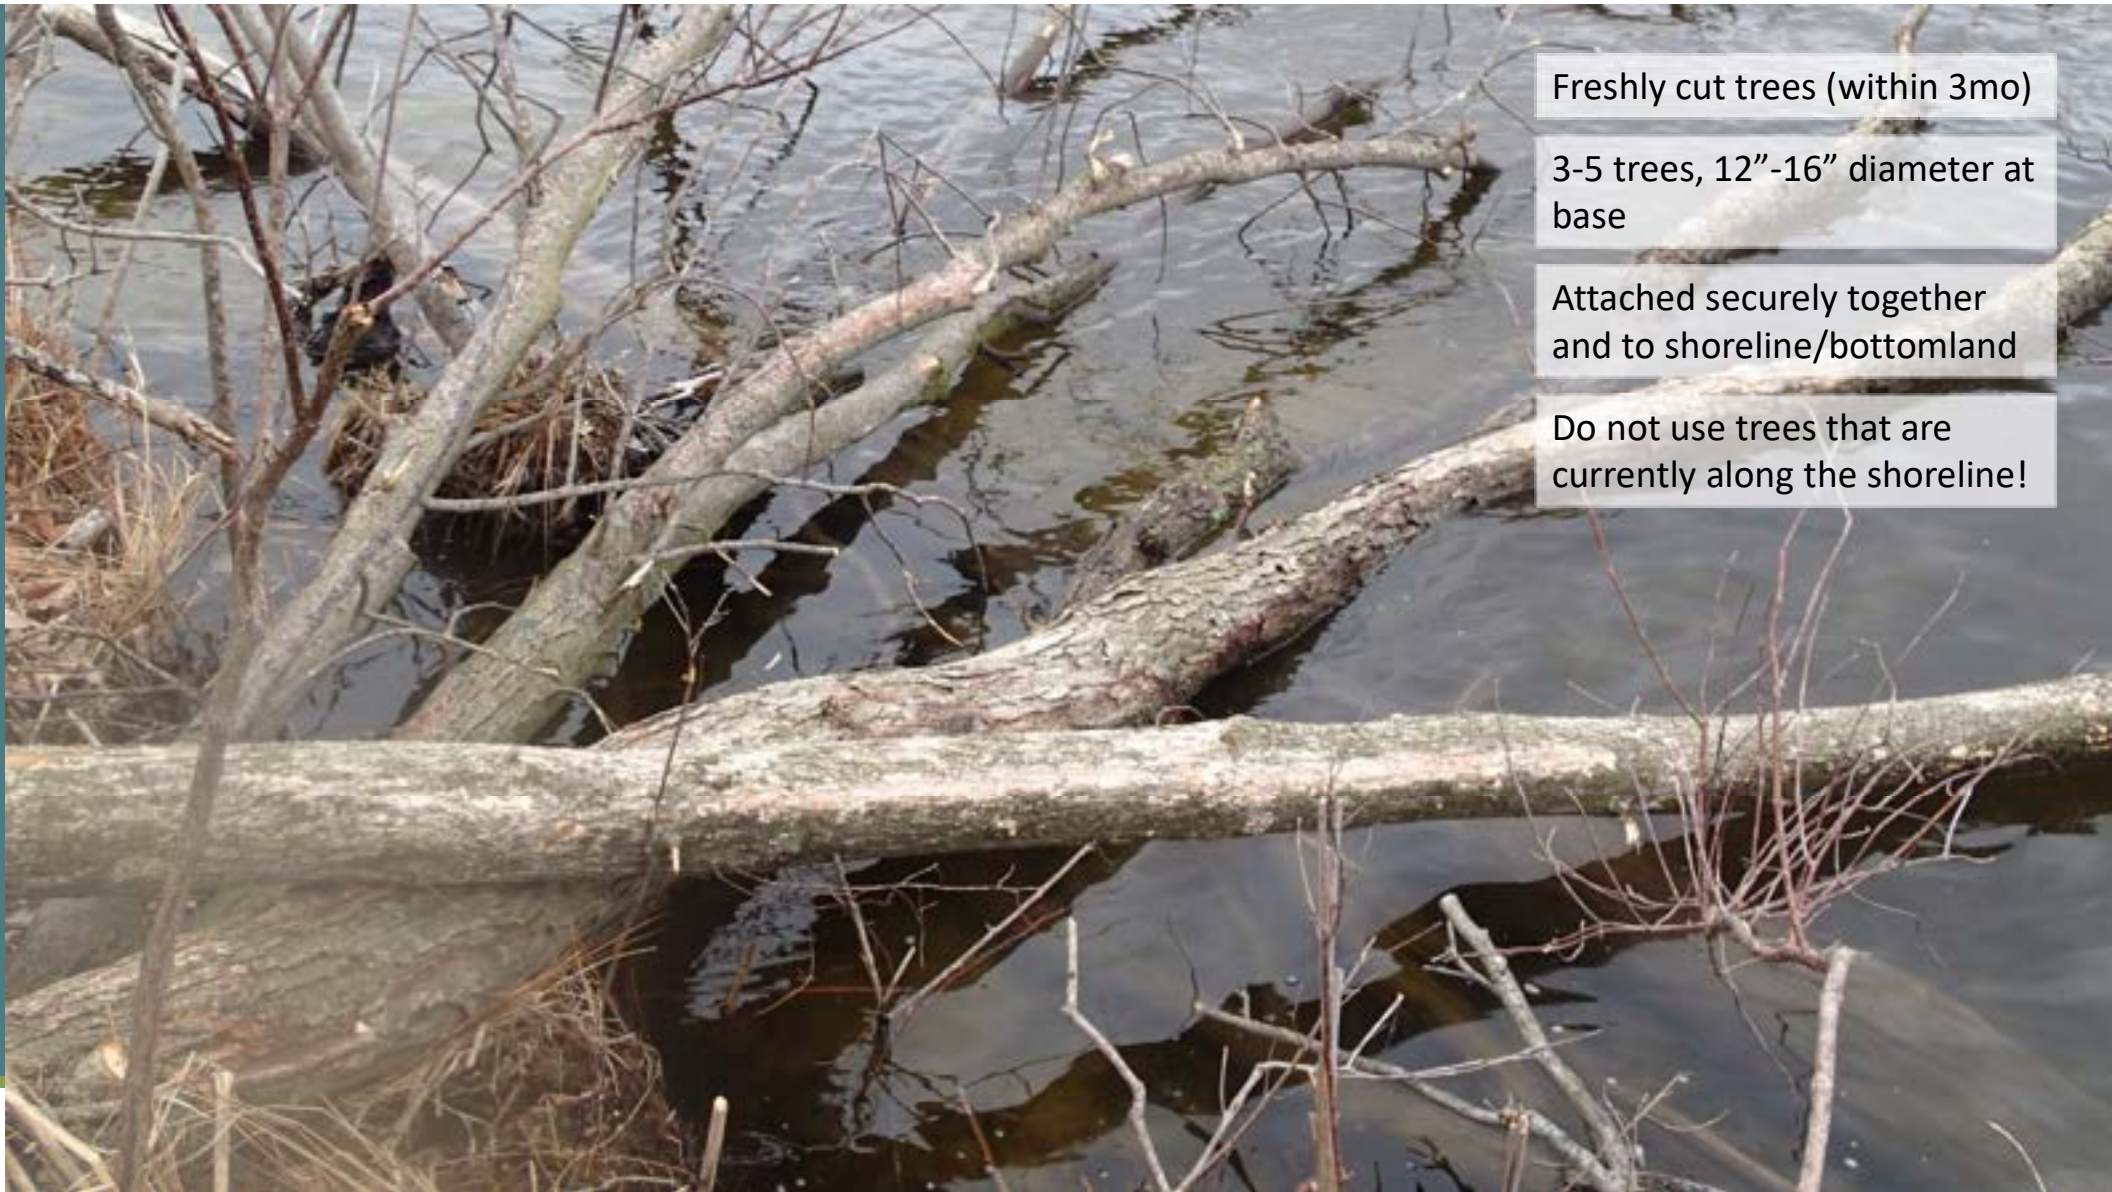
Example designs – Fish Sticks cluster

Freshly cut trees (within 3mo)

3-5 trees, 12"-16" diameter at base

Attached securely together and to shoreline/bottomland

Do not use trees that are currently along the shoreline!
