MICHIGAN DEPARTMENT OF
ENVIRONMENT, GREAT LAKES, AND ENERGY

Shoreline Trends and Best Management Practices: Combatting cumulative impacts through homeowner scale techniques

WETLANDS, LAKES, AND STREAMS PROGRAM

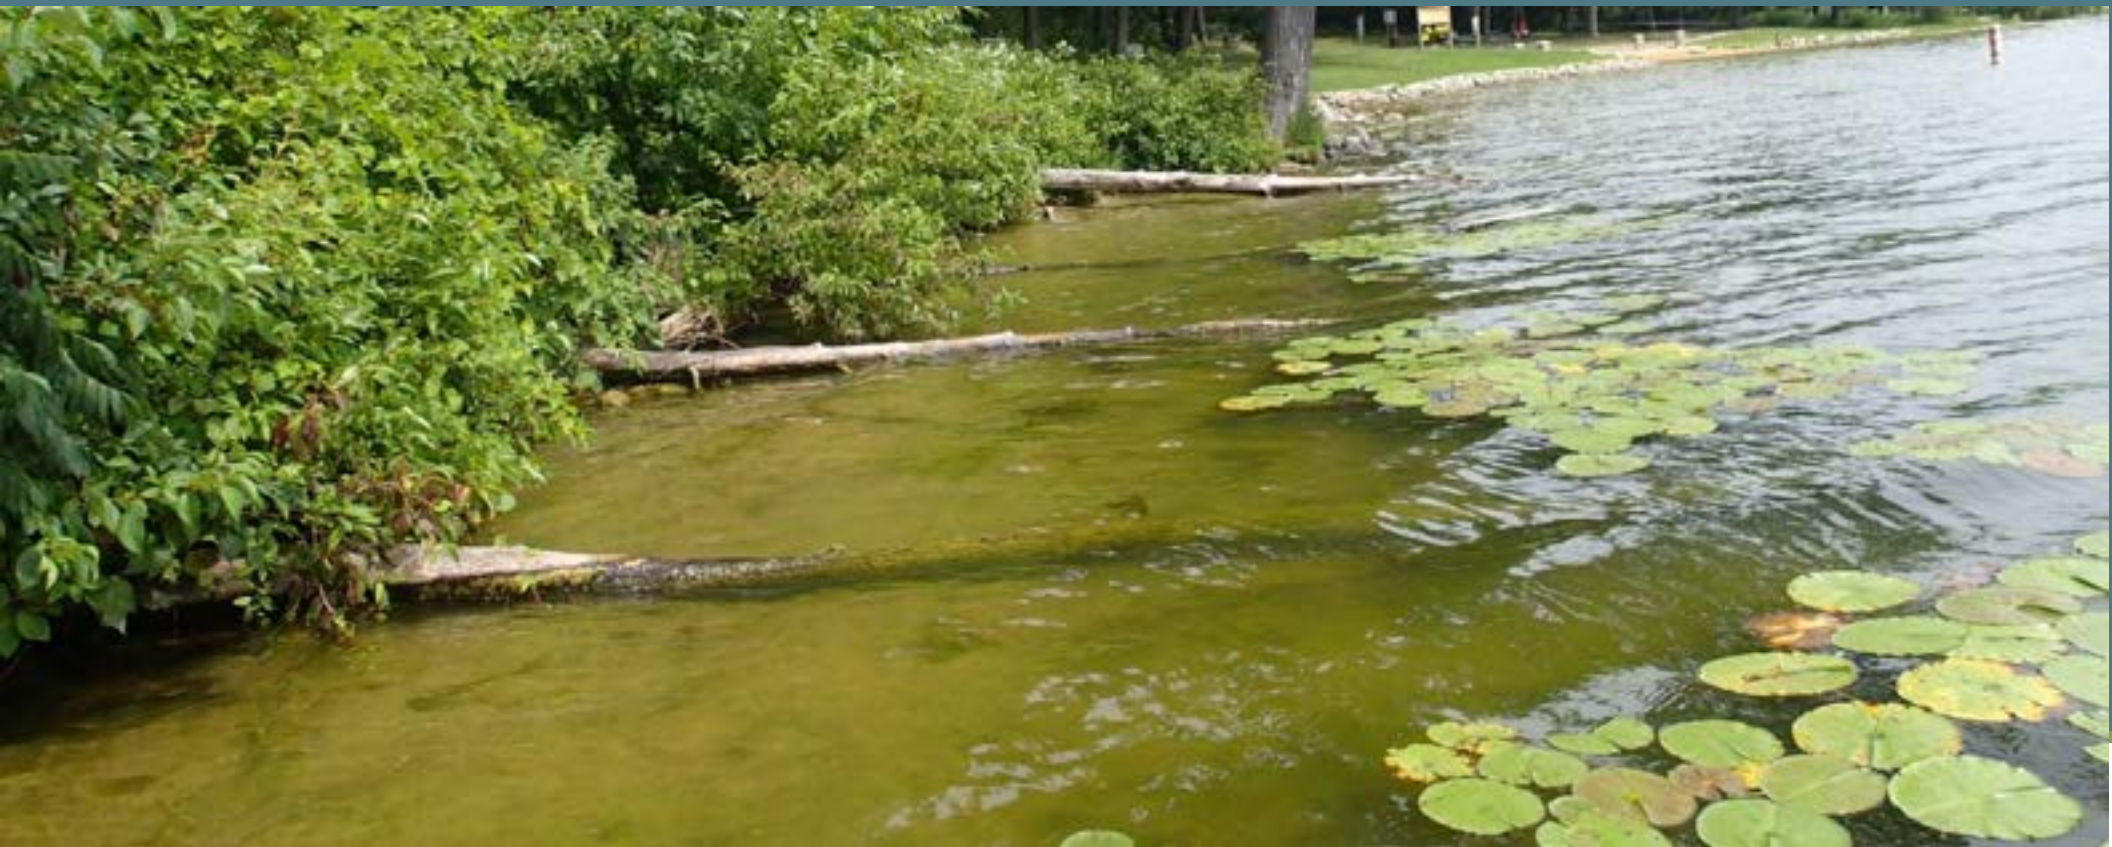
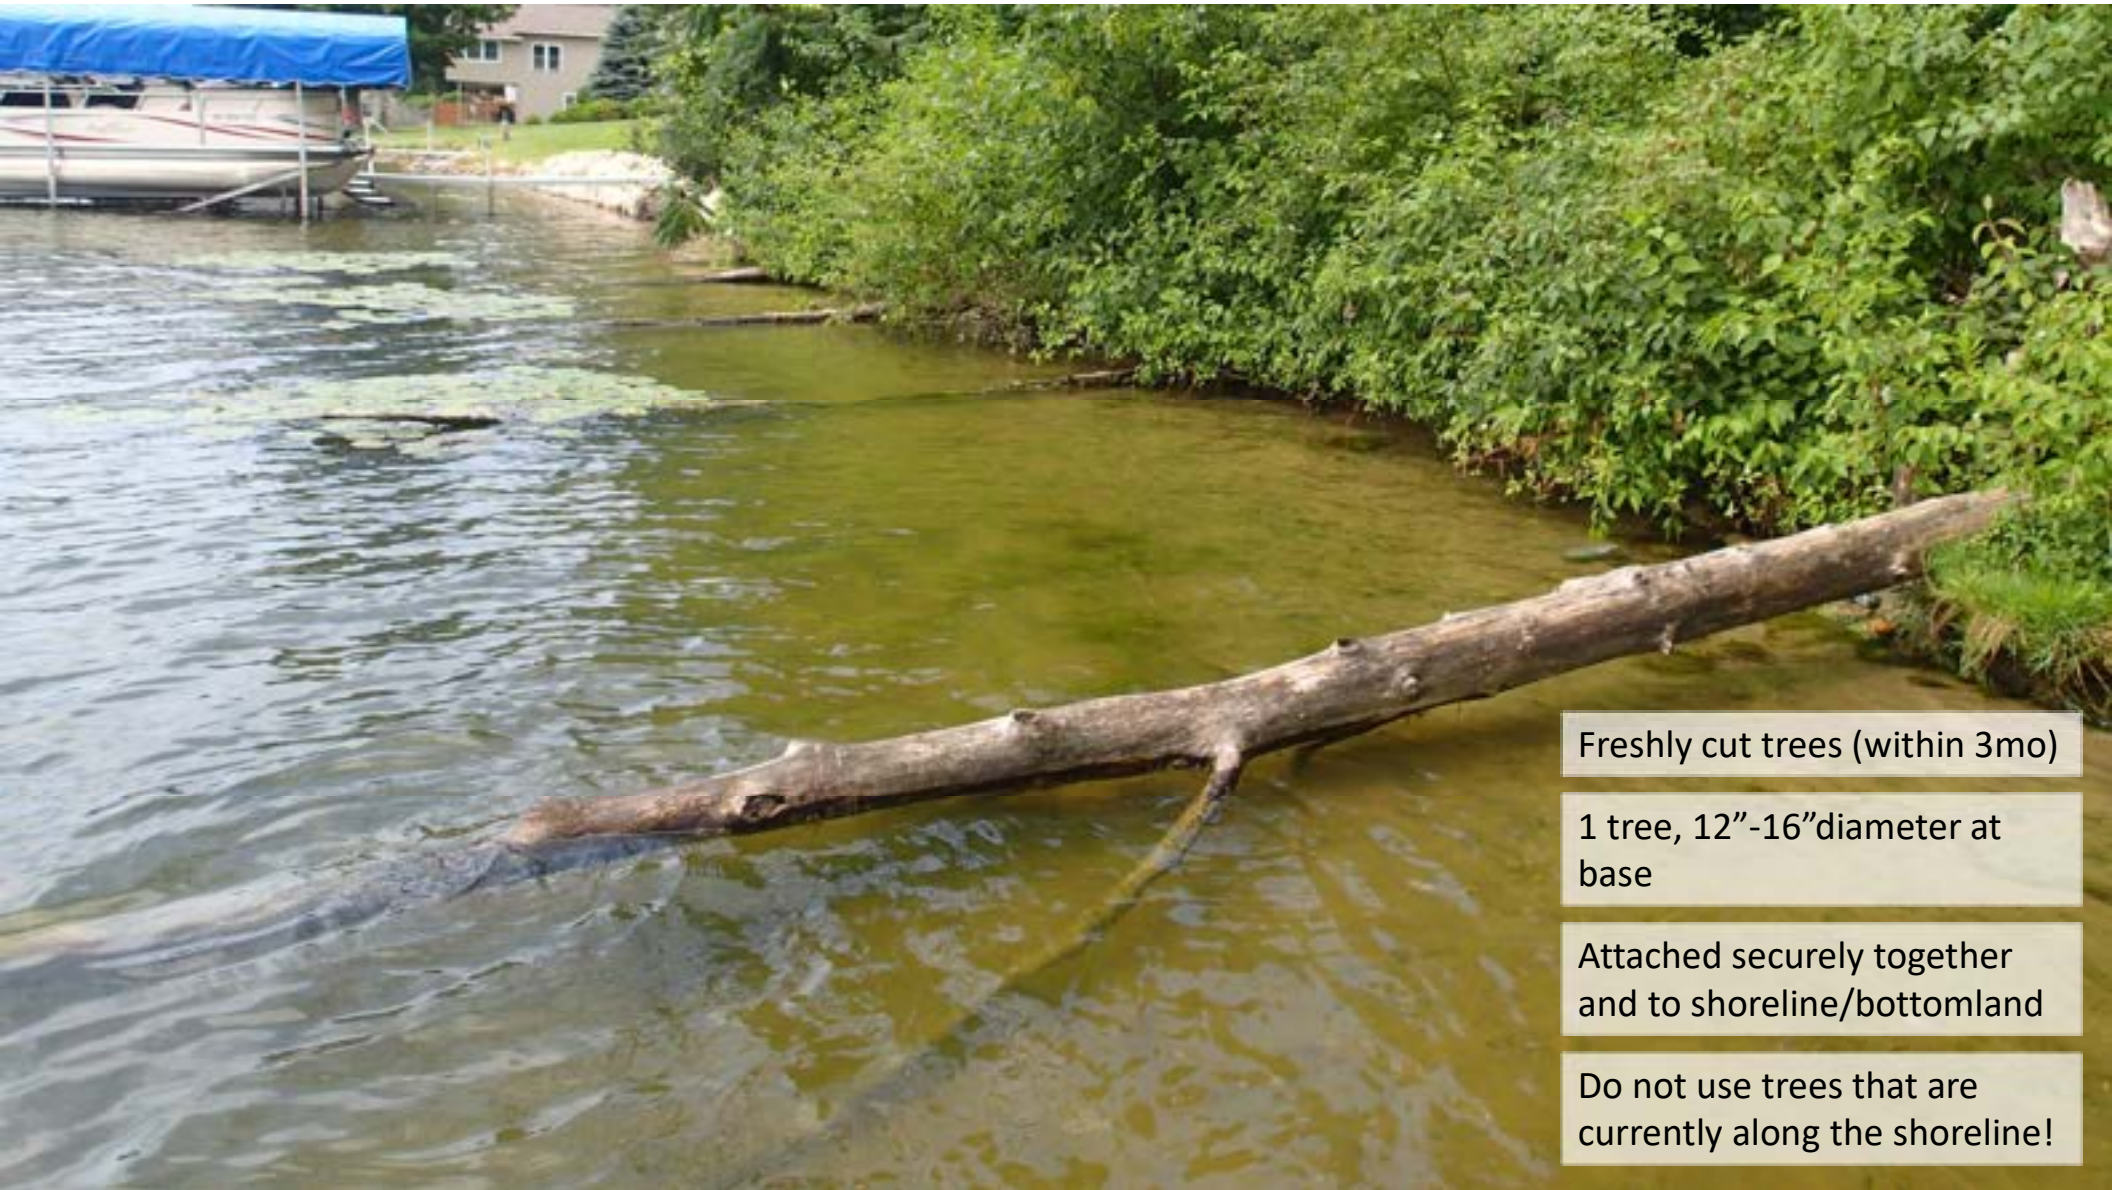
Example designs – Single Fish Stick series

Freshly cut trees (within 3mo)

1 tree, 12"-16" diameter at base

Attached securely together and to shoreline/bottomland

Do not use trees that are currently along the shoreline!

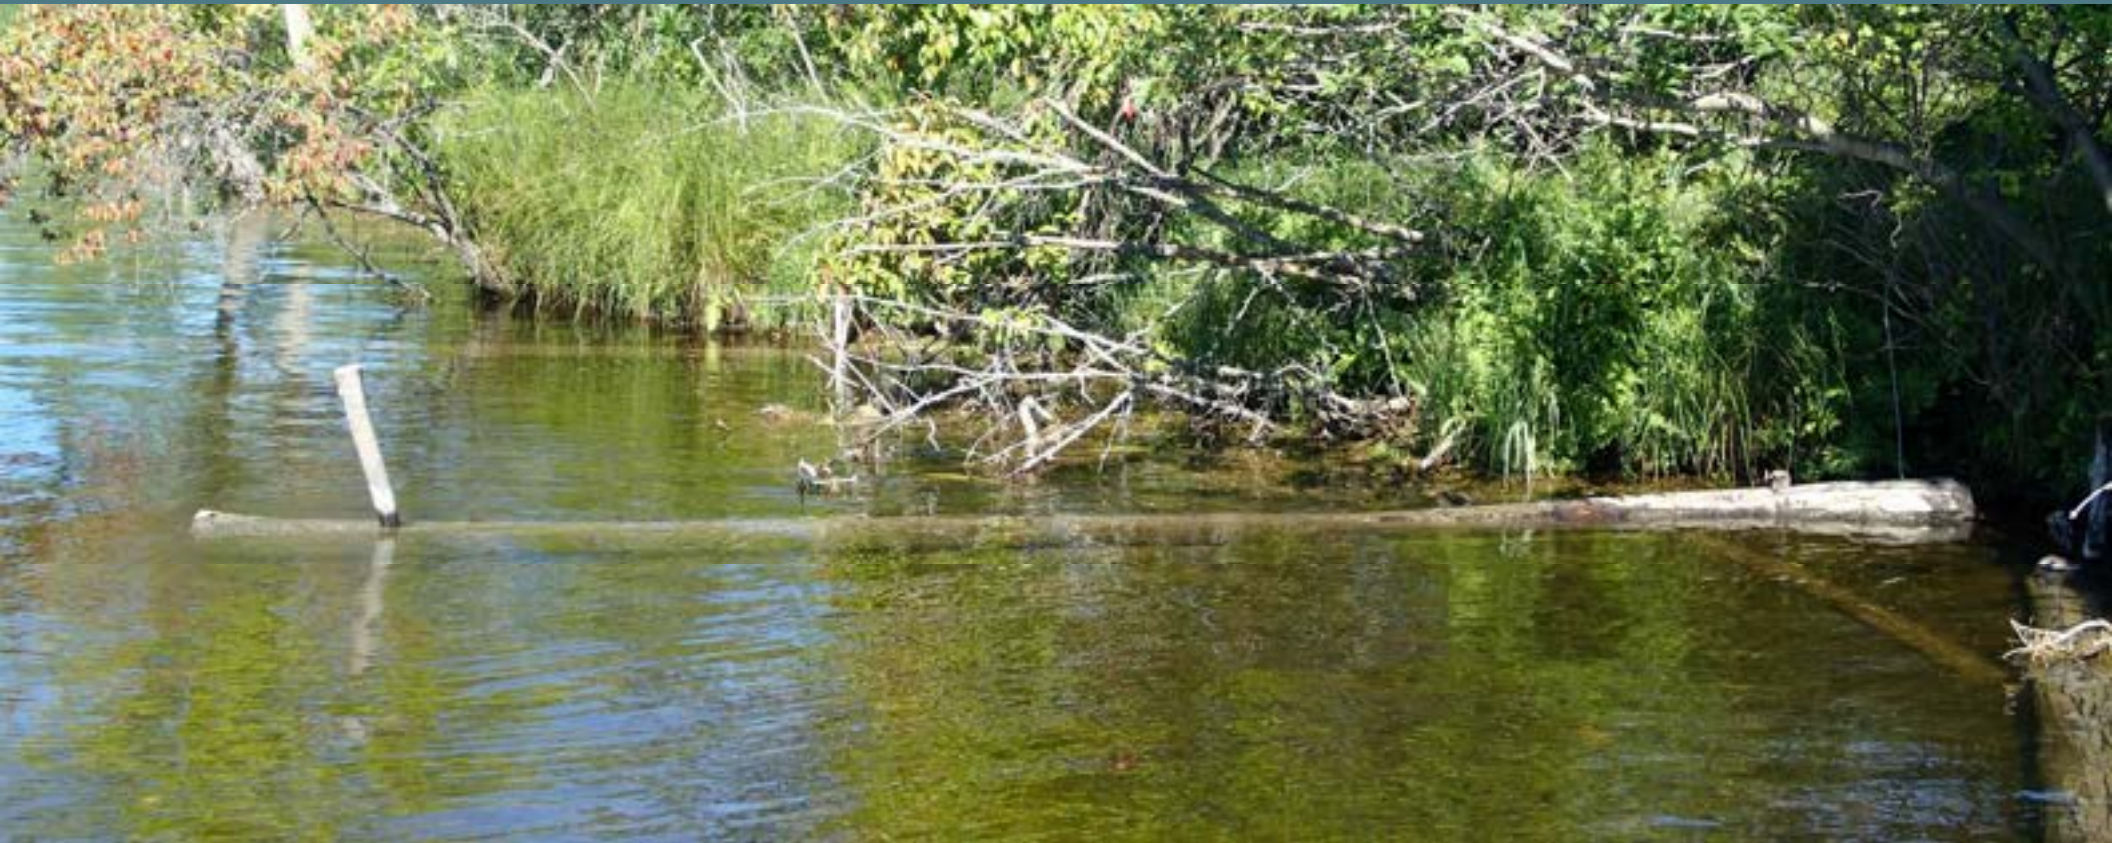
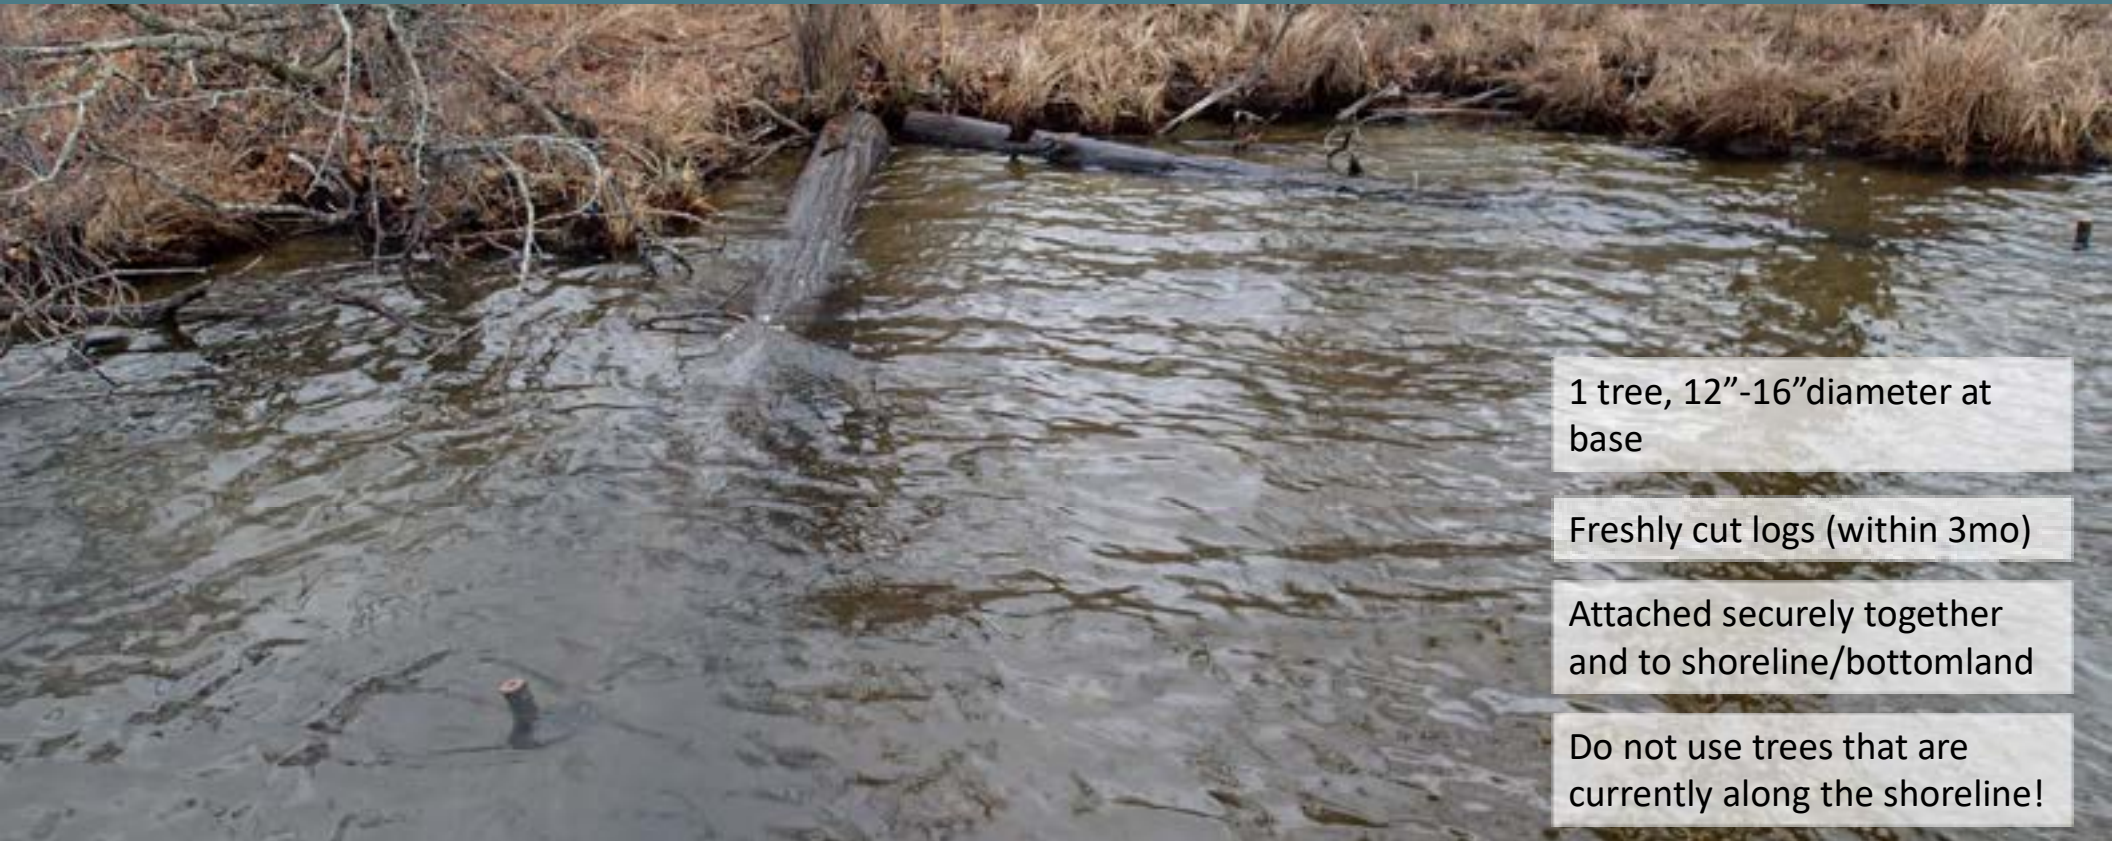
Example designs – Turtle Log series

1 tree, 12"-16" diameter at base

Freshly cut logs (within 3mo)

Attached securely together and to shoreline/bottomland

Do not use trees that are currently along the shoreline!

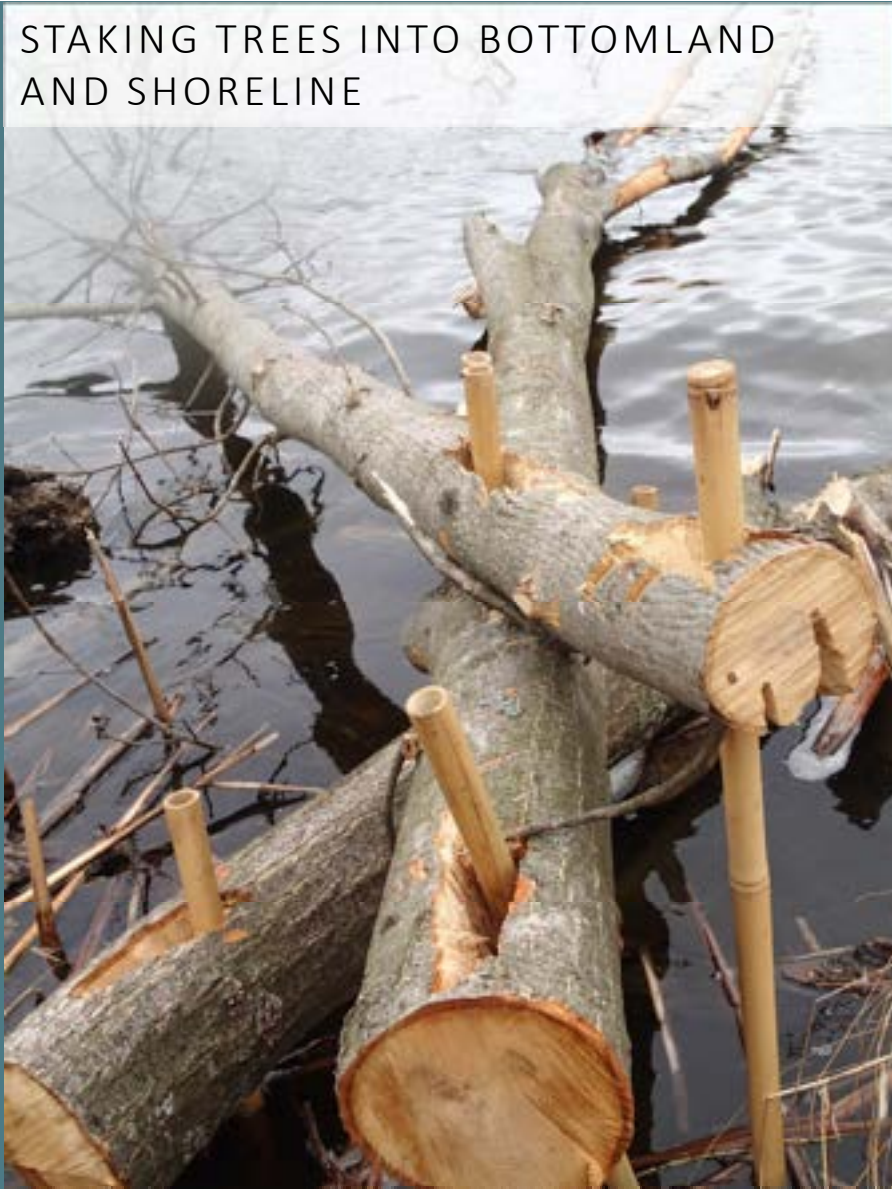
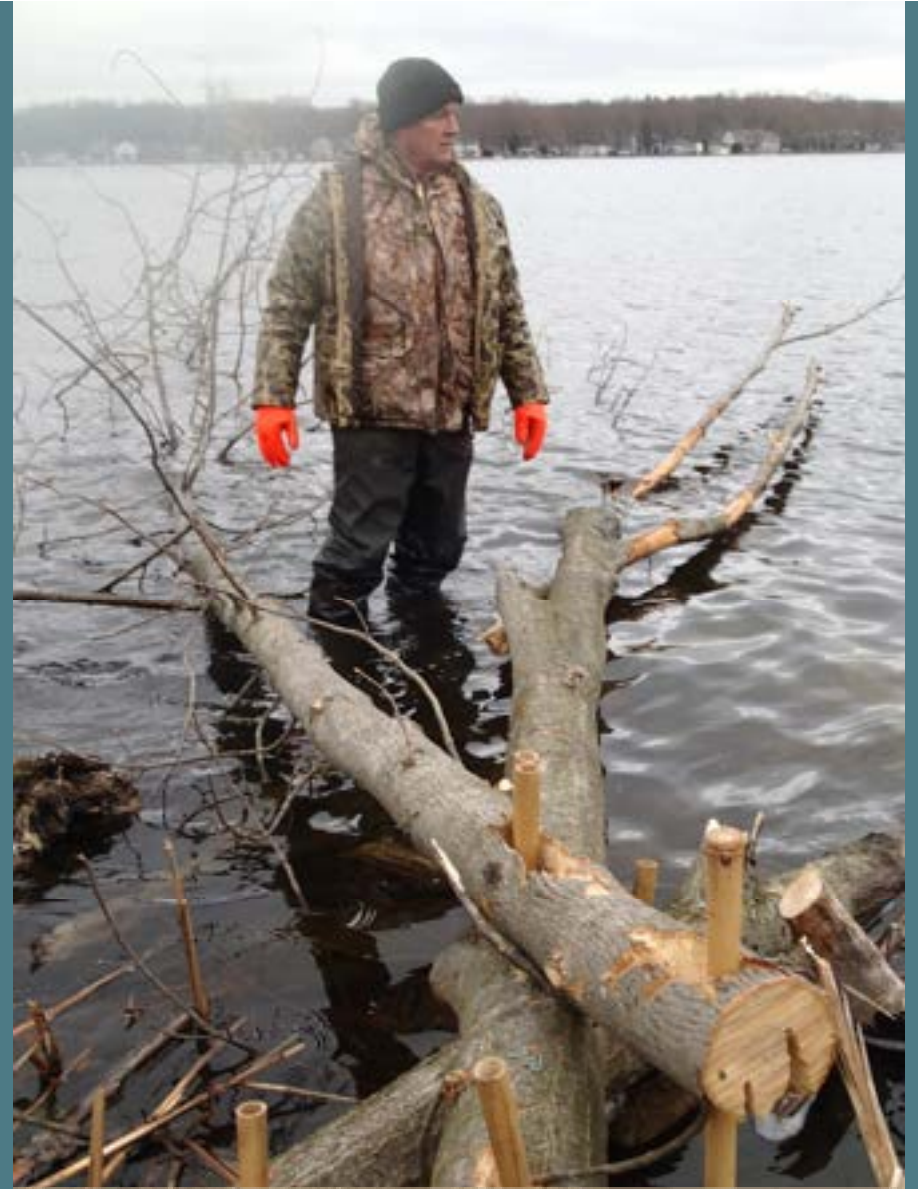
STAKING TREES INTO BOTTOMLAND
AND SHORELINE

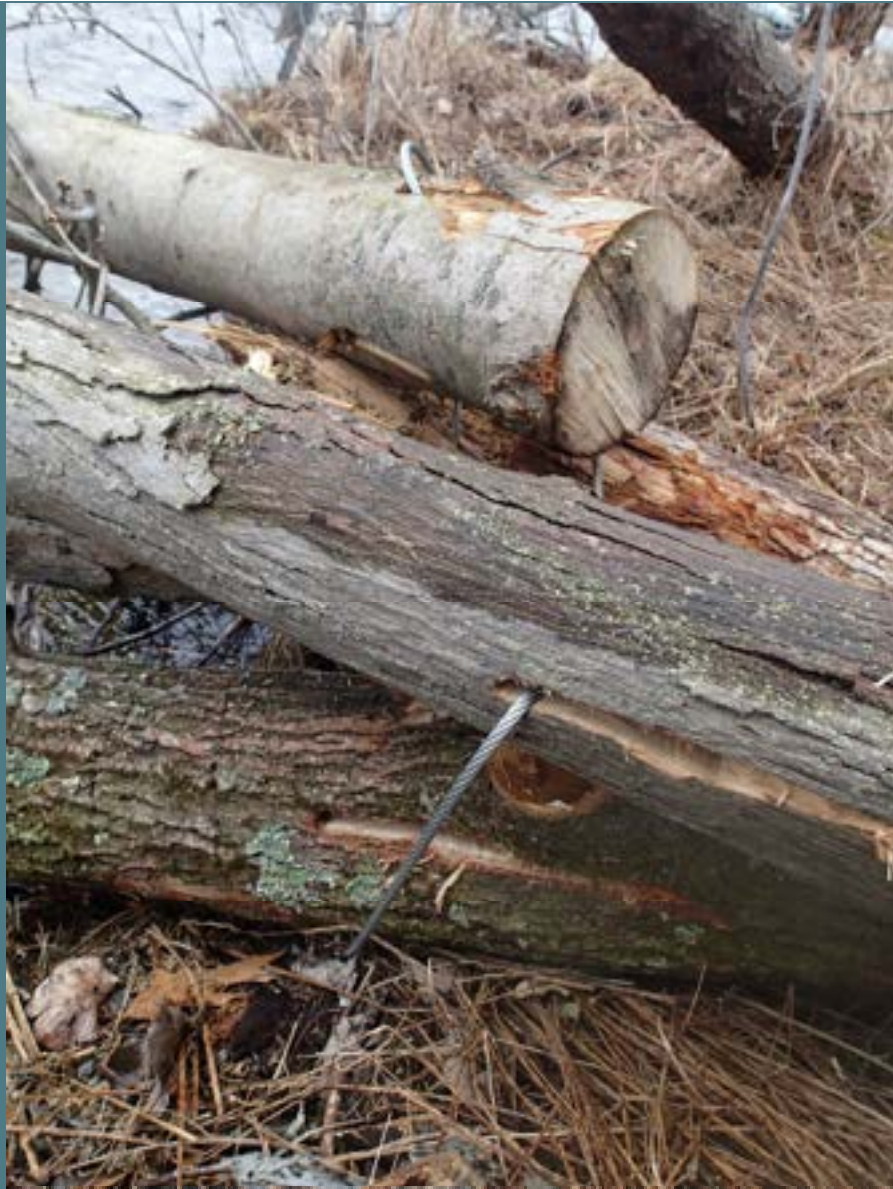
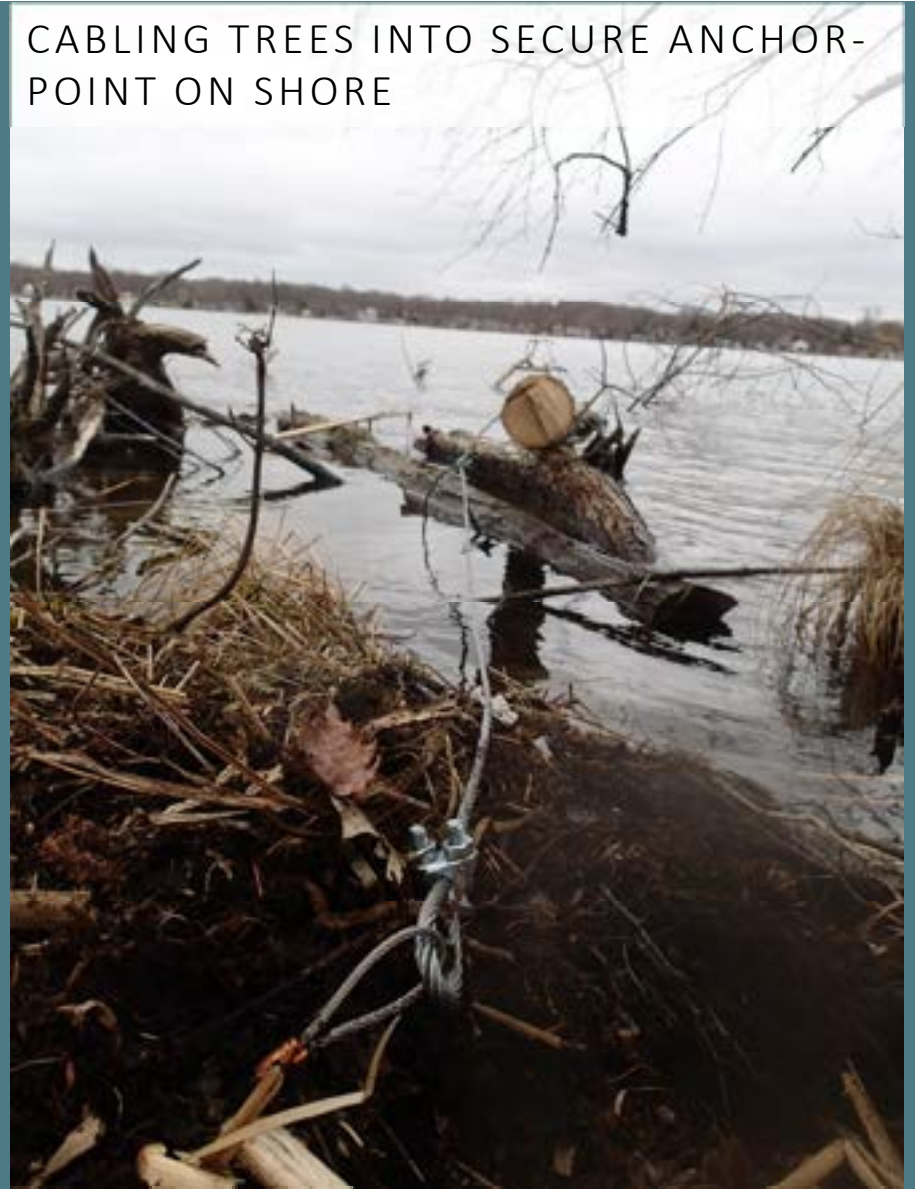
CABLING TREES INTO SECURE ANCHOR-
POINT ON SHORE

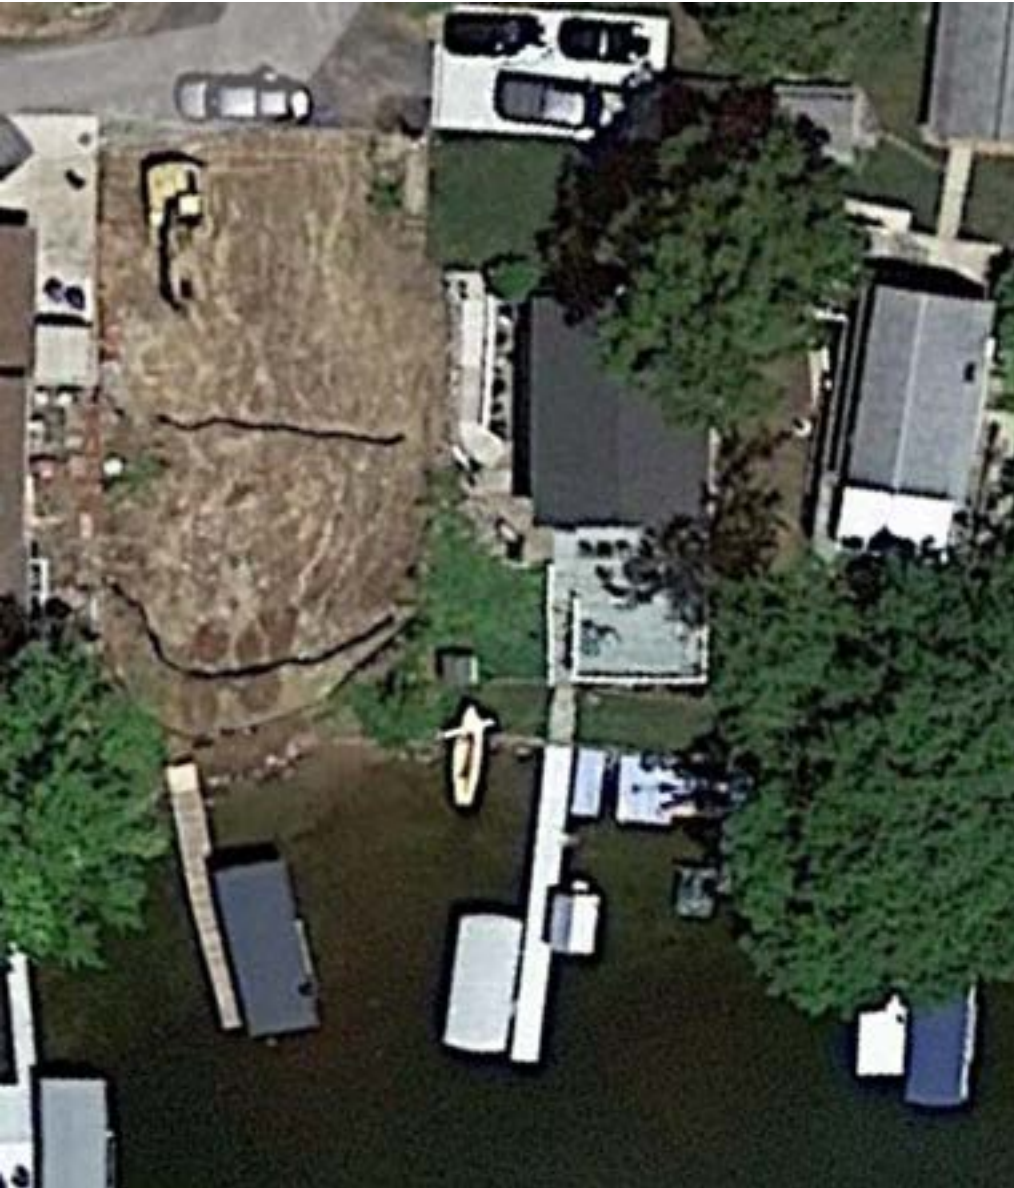
PLANTING VIEW DETAIL/LEGEND

- Item 1 : MONARDA FISTULOSA OR CORCORIS LANCEOLATA BARR
 - Item 2 : SPIRAEA ALBA D. ROY OR CAREX HYSTERICINA
- NOT TO SCALE
- DIMENSIONS LISTED
- PREVIOUS ATTACHMENTS REMAIN UNCHANGED
- Approved
- Issued On: 12/09/2022
- Expires On: 12/09/2027

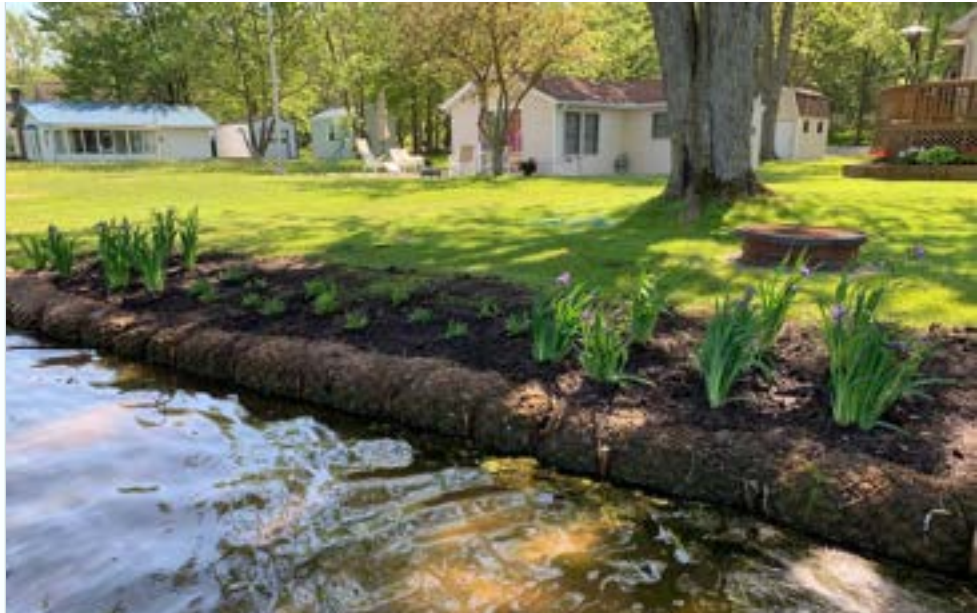
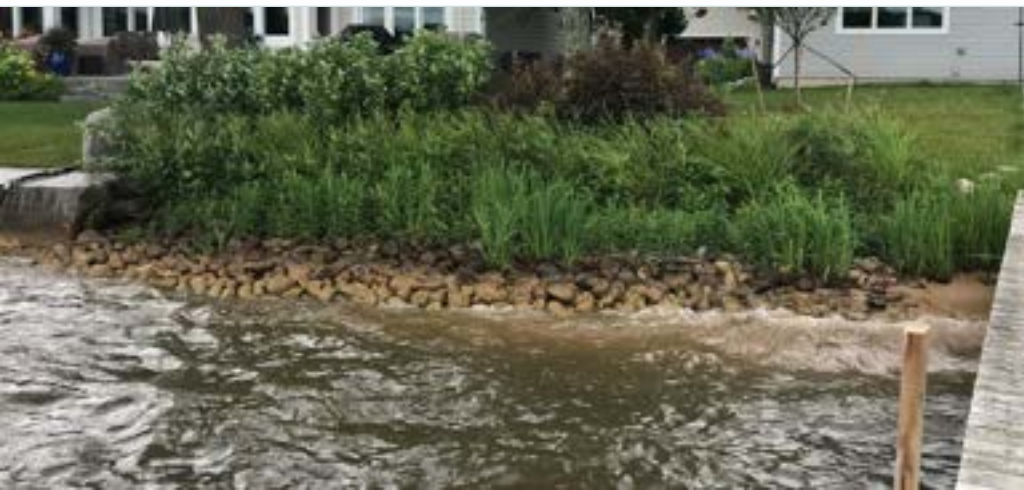
BIOG PLACEMENT AT BANK TOE

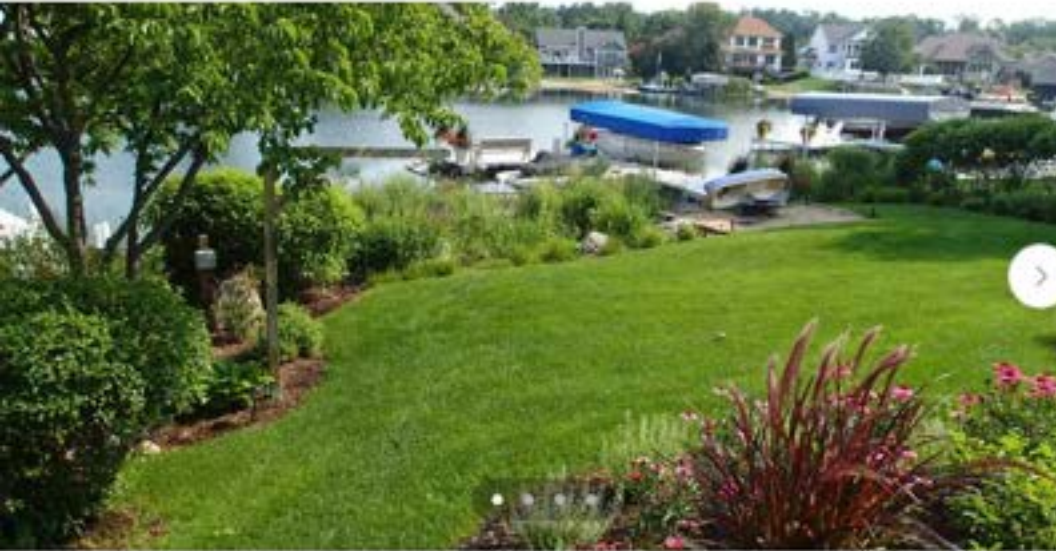
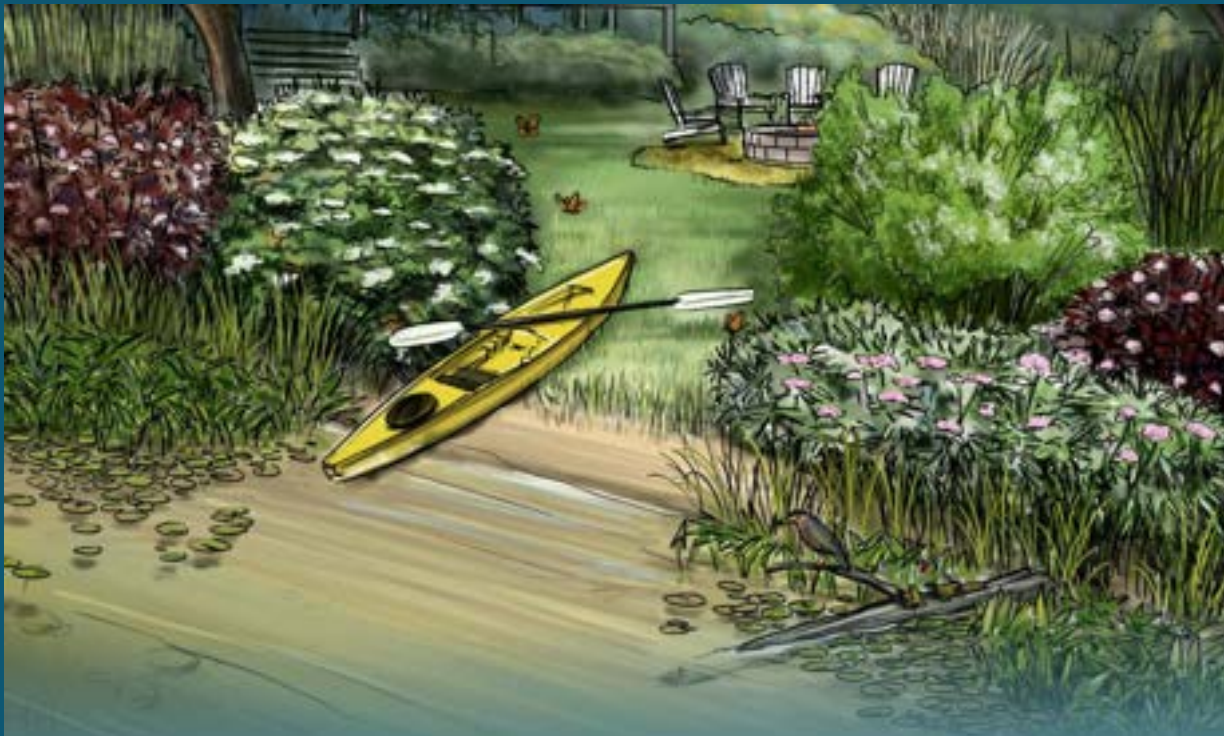
Diamond Lake, Cass County

Picture Description: The first and second pictures show the installed bioengineering project in 2021. The third image is the plans submitted with the permit application. The last picture shows this shoreline in 2017 before bioengineering was installed.

Design: Bioengineering

Fetch and boating activity: Maximum fetch = 0.24 miles. Average depth across maximum fetch line = 1.6 feet. Maximum wave height = 0.47 feet. Site is near the inside of a smaller bay that is connected to a larger lake. Boat speeds are generally low and dominant watercraft consist mainly of pontoon boats, smaller vessels, and fishing boats.

Installation cost: ~\$277 per linear foot. Included in that cost was the demolition and removal of the existing concrete seawall

Plant list: *Carex bricknelli*, various sedges, lilies, and vegetated coir mats, in addition to mixed upland plantings of native and hybrid plants.
